**APPENDIX N**  
**PRELIMINARY GEOTECHNICAL INVESTIGATION RESULTS**

Shell Wind Energy, Inc  
Hermosa Wind Project

Subject: Preliminary Geotechnical Investigation Results

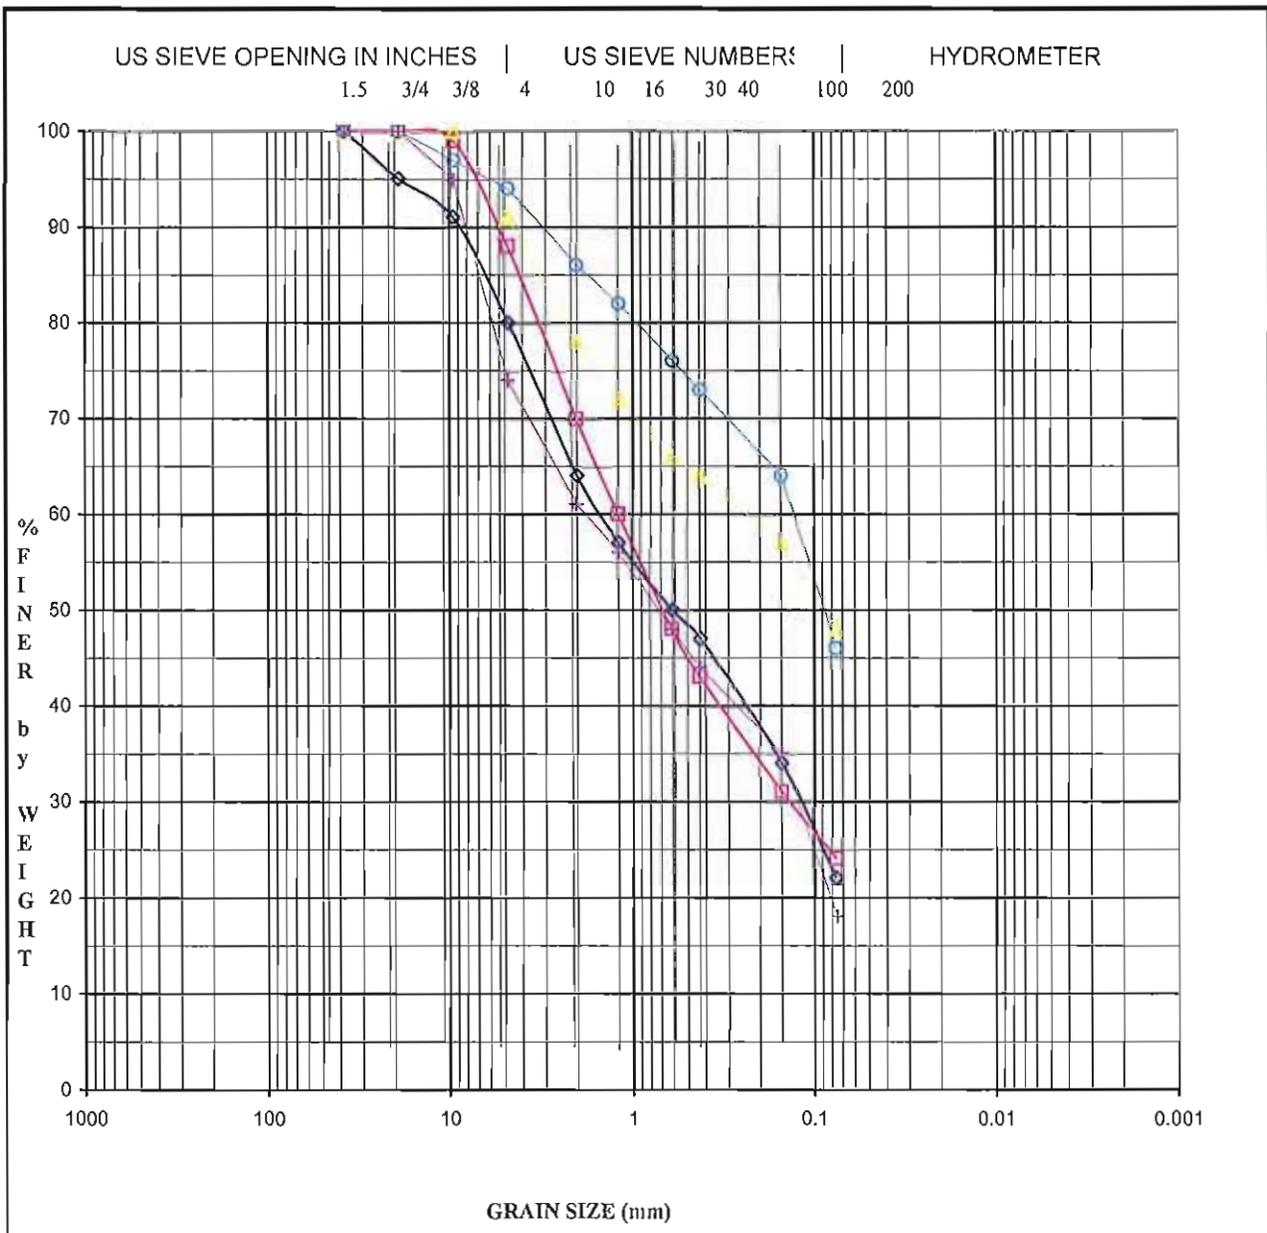
COBBLES	GRAVEL		SAND			SILT OR CLAY
	COARSE	FINE	CRS	MED	FINE

Specimen I.D.	Description	USCS	AASHTO	Group Index	LL	PI	PL		
◇ BV-01 @ 0-5 FEET	CLAYEY SAND	SC	A-2-6	0	25	11	14		
□ BV-02 @ 0-5 FEET	CLAYEY SILTY SAND	SC-SM	A-1-b	0	23	5	18		
△ BV-03 @ 0-5 FEET	CLAYEY SAND	SC	A-6	5	32	19	13		
○ BV-04 @ 0-5 FEET	CLAYEY SAND	SC	A-6	2	26	13	13		
† BV-05 @ 0-5 FEET	SILTY SAND	SM	A-1-b	0	NP	NP	NP		
Specimen I.D.	D100	D60	D30	D10	Cc	Cu	%Gravel	%Sand	%Silt&Clay
◇ BV-01 @ 0-5 FEET	37.50	1.53	0.125				20	58	22
□ BV-02 @ 0-5 FEET	19.00	1.18	0.139				12	64	24
△ BV-03 @ 0-5 FEET	9.50	0.27					9	43	48
○ BV-04 @ 0-5 FEET	19.00	0.13					6	48	46
† BV-05 @ 0-5 FEET	19.00	1.84	0.128				26	56	18

Index testing of the soils encountered in the borings indicates that the soils are fairly consistent classifying as either clayey sand or silty sand (SC and SM). Fines contents were generally less than 20 percent and liquid limits indicating low plasticity soils. One laboratory compaction test was performed indicating a reasonable compaction curve and also suggesting that soil tested was rather dry compared to the optimum moisture content for compaction. The results of the one thermal resistivity test of one sample are presented in Attachment B.

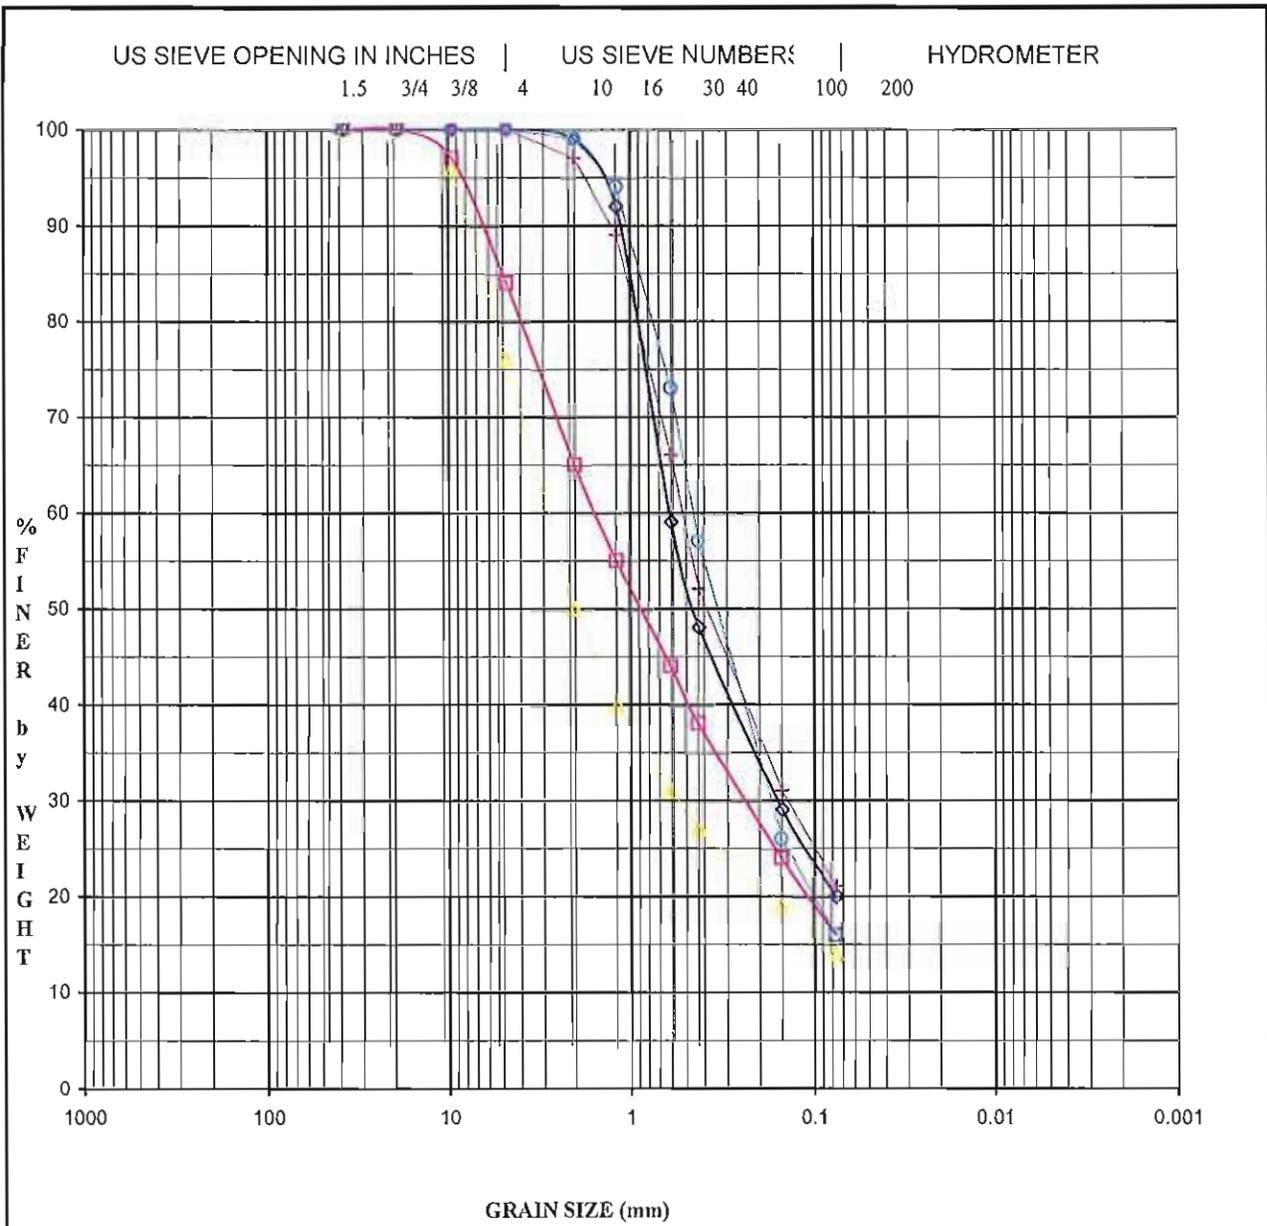
COBBLES	GRAVEL		SAND			SILT OR CLAY
	COARSE	FINE	CRS	MED	FINE

Specimen I.D.	Description	USCS	AASHTO	Group Index	LL	PI	PL
◇ BV-05 @ 14 FEET	SILTY SAND	SM	A-1-b	0	NP	NP	NP
□ BV-01 @ 6 FEET	SILTY SAND	SM	A-1-b	0	NP	NP	NP
△ BV-03 @ 19 FEET	SILTY SAND	SM	A-1-a	0	NP	NP	NP
○ BV-05 @ 9 FEET	CLAYEY SAND	SC	A-2-6	0	38	25	13
† BV-05 @ 7.5 FEET	CLAYEY SAND	SC	A-2-6	0	38	24	14

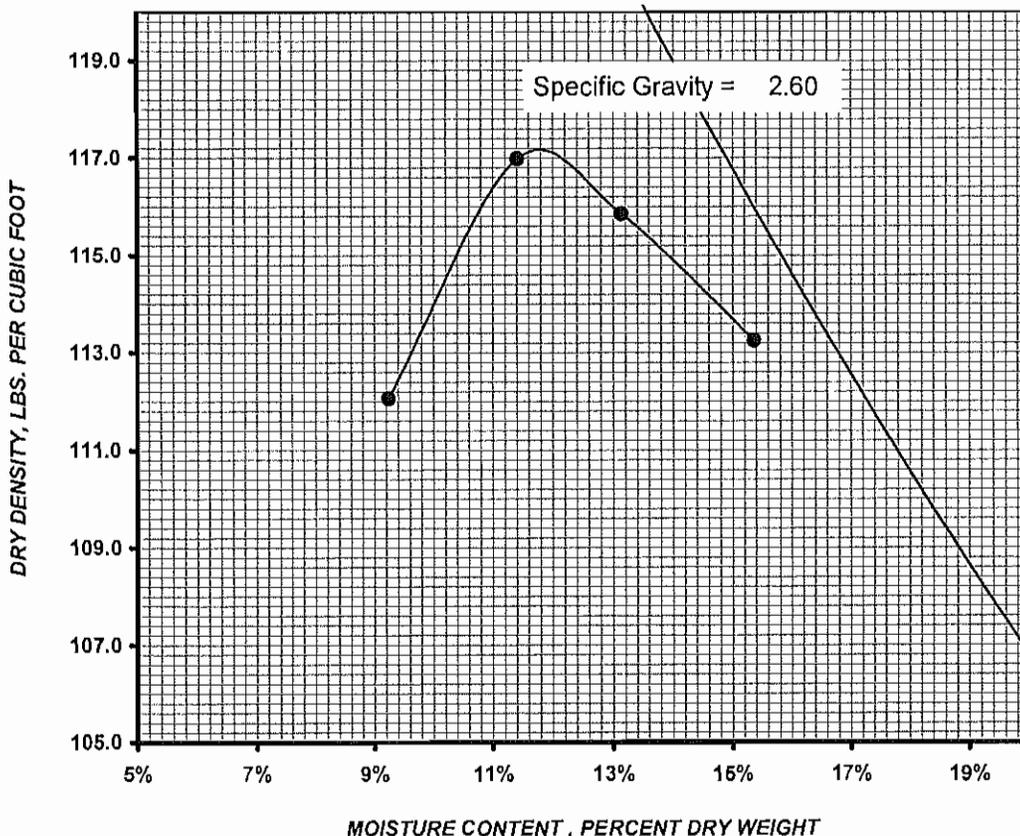
**REPORT OF MOISTURE DENSITY RELATIONSHIP OF SOIL**

**Sample Source:** 0 to 5 feet  
**Sample Classification:** A-6 ( 4 ) SC Clayey SAND  
**General Description:**  
**Test Method:** ASTM D698 Method A  
**Rammer:** manual      **Method of Preparation:** (dry)  
**Atterberg Limits (AASHTO T-89/T-90)**  
 LL: 28    PL: 12    PI: 16  
**Specific Gravity:** 2.60 (estimate)  
**Maximum Dry Density (pcf):** 117.2  
**Optimum Moisture Content (%):** 11.6

Delivered Moisture Content (%) 5.3

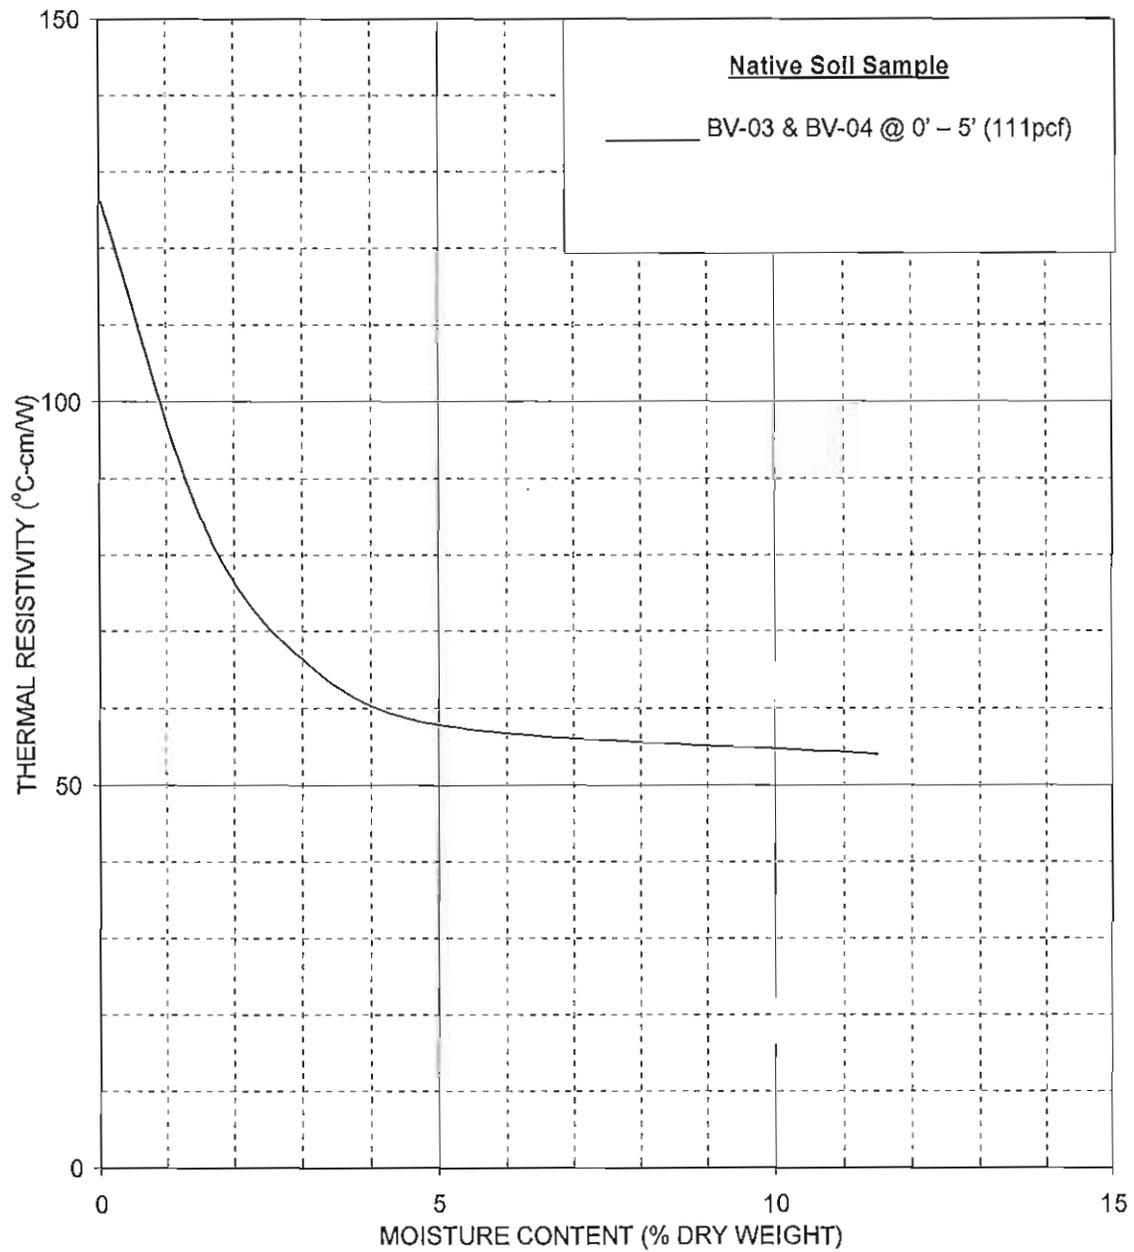
### THERMAL DRYOUT CURVE

Native Soil Thermal Analysis

For thermal dryout characterization, the sample was tested at **95% of the Standard Proctor density (117pcf) and at 11.5% moisture content.** The testing was conducted in accordance with the IEEE Standard and the thermal dryout curve is presented in **Figure 1.**

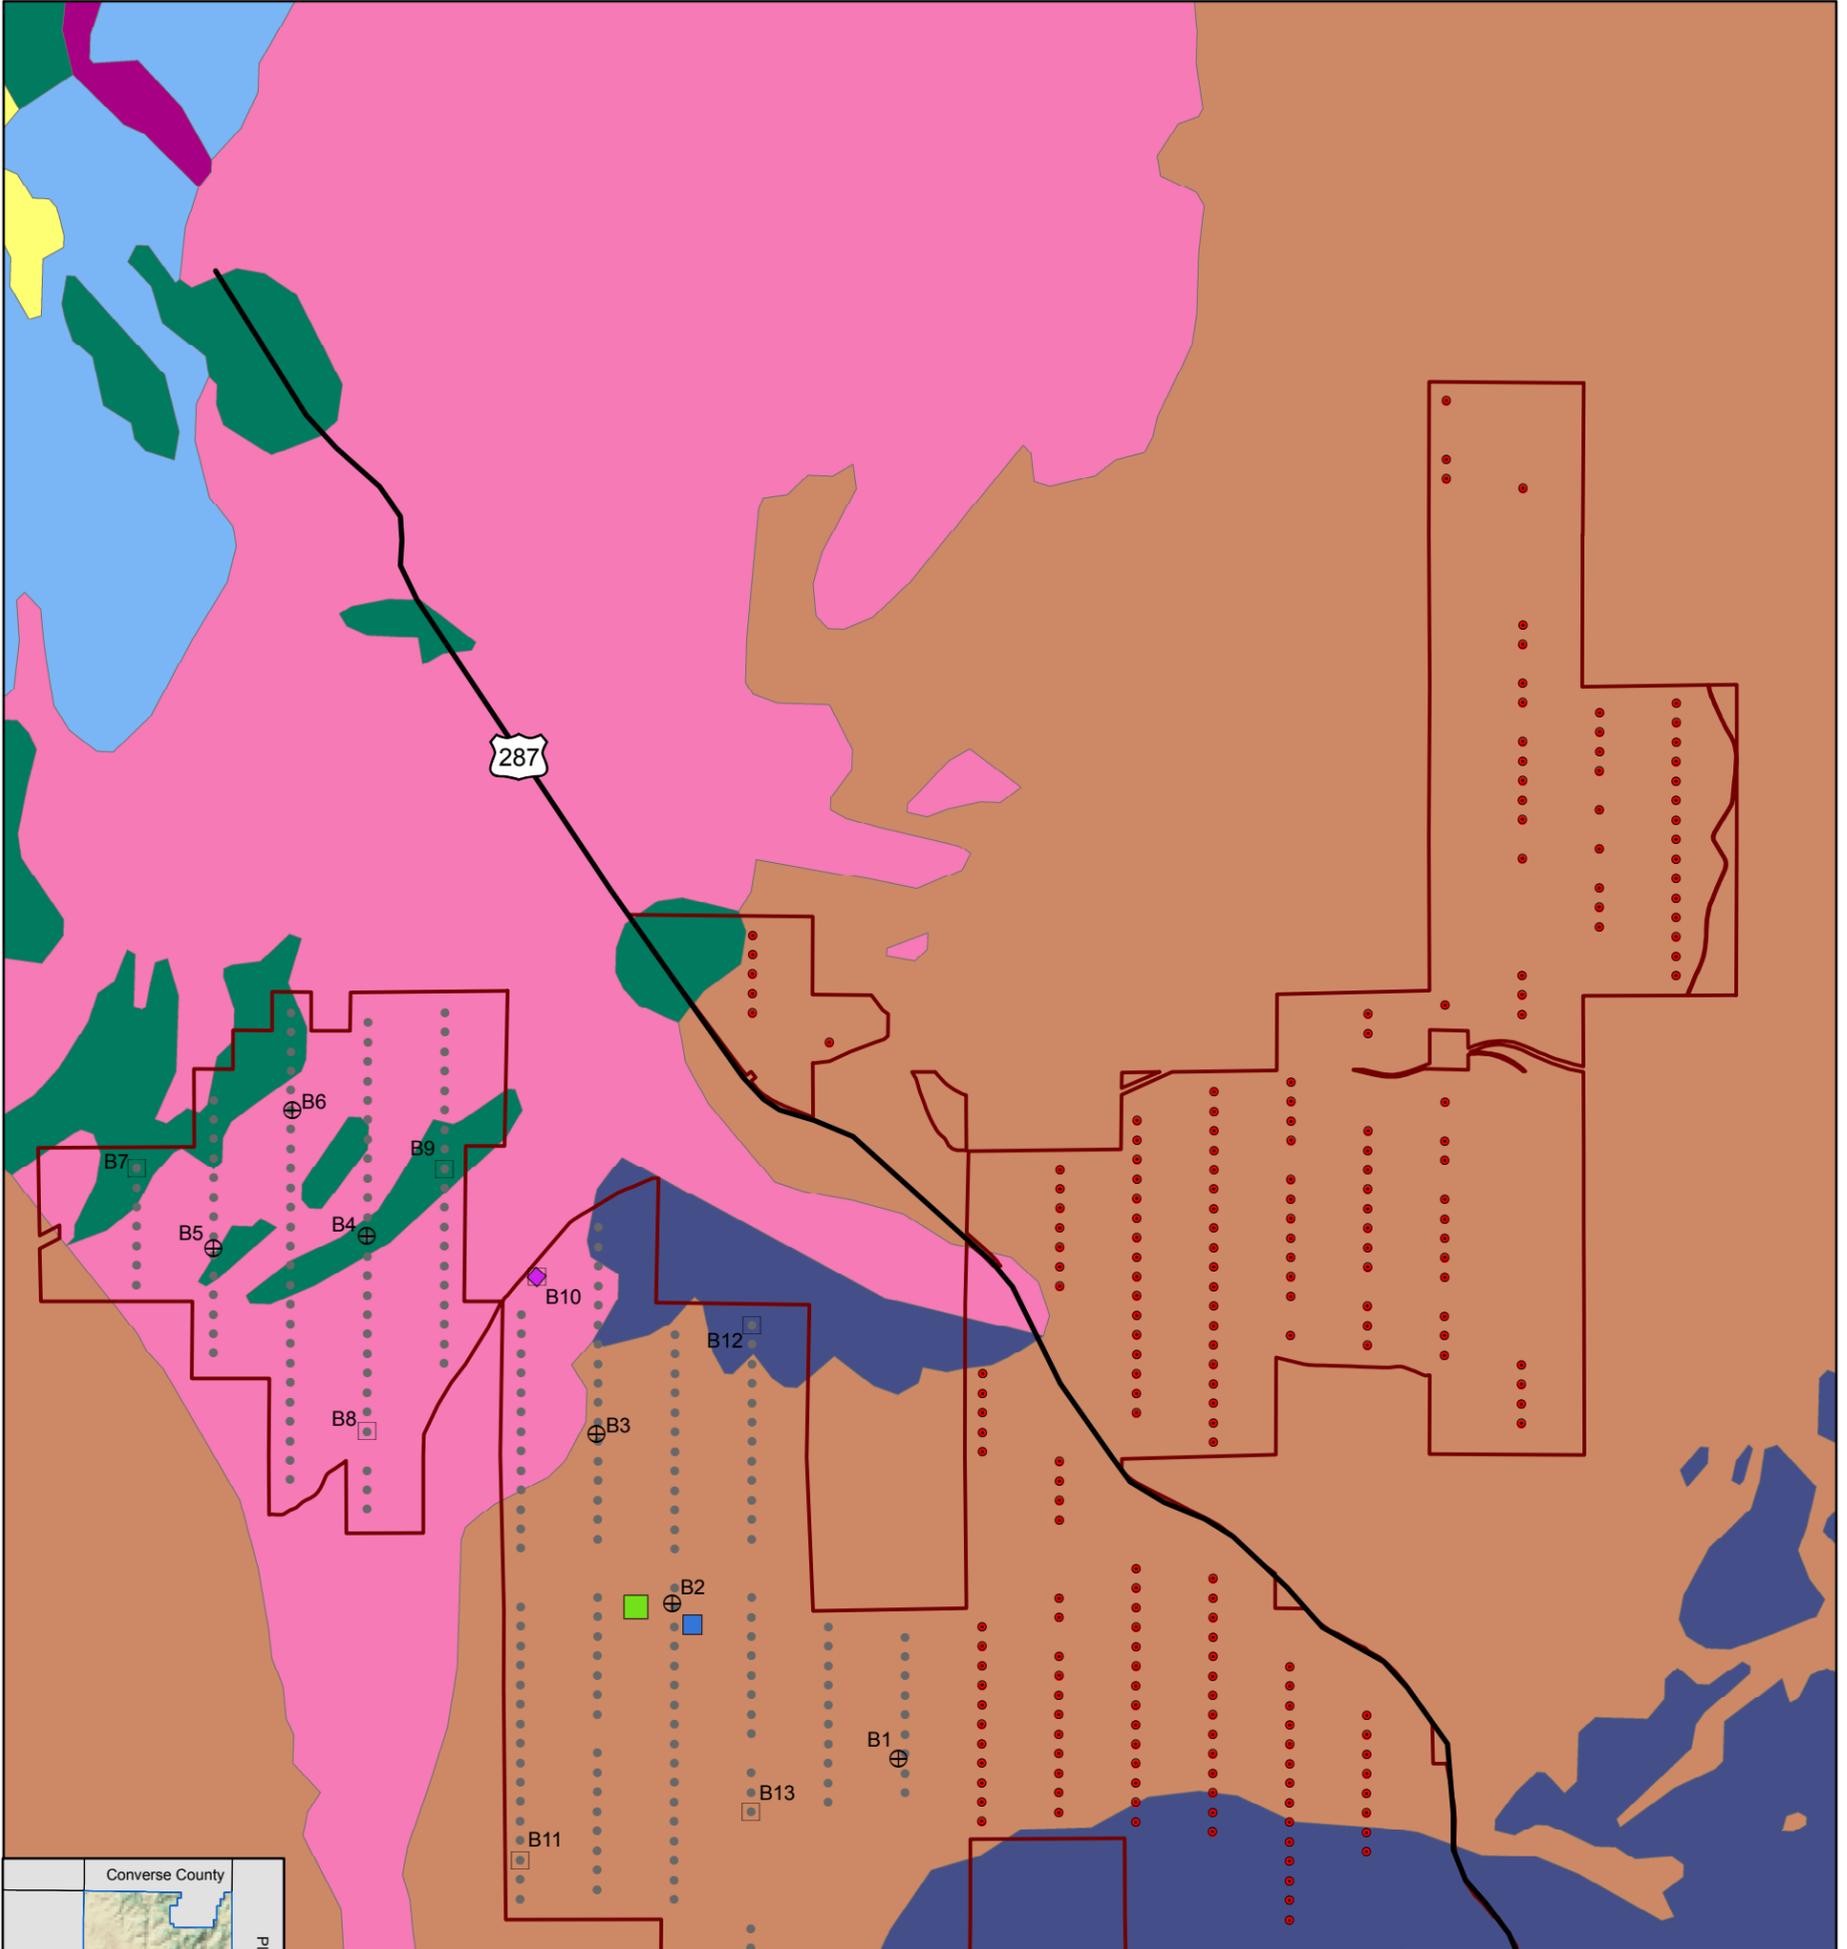
Attachment A - Boring Location Map

Boring	Easting (ft)	Northing (ft)	Longitude (degrees)	Latitude (degrees)	Depth (ft)	Remarks
B7	1479614	14917722	-105.5834	41.0722	50	If top of bedrock is less than 50 feet, then core 10 feet into bedrock; Collect bag sample 0 to 5 feet
B8	1487469	14908719	-105.5547	41.0476	50	If top of bedrock is less than 50 feet, then core 10 feet into bedrock; Collect bag sample 0 to 5 feet
B9	1490110	14917702	-105.5453	41.0723	50	If top of bedrock is less than 50 feet, then core 10 feet into bedrock; Collect bag sample 0 to 5 feet
B10	1493265	14914002	-105.5338	41.0622	50	If top of bedrock is less than 50 feet, then core 10 feet into bedrock; Collect bag sample 0 to 5 feet
B11	1492688	14894061	-105.5355	41.0074	50	If top of bedrock is less than 50 feet, then core 10 feet into bedrock; Collect bag sample 0 to 5 feet
B12	1500595	14912355	-105.5072	41.0578	50	If top of bedrock is less than 50 feet, then core 10 feet into bedrock; Collect bag sample 0 to 5 feet

B13	1500563	14895711	-105.5069	41.0121	50	If top of bedrock is less than 50 feet, then core 10 feet into bedrock; Collect bag sample 0 to 5 feet

The subsurface conditions were investigated by drilling six additional borings (B7 through B11 and B13) on November 2 through 5, 2009. The approximate locations of the additional test borings are shown in Attachment A. Photos of each of the test locations are included in the CRA cultural resource report (Attachment C). Test borings are listed in Table 1.

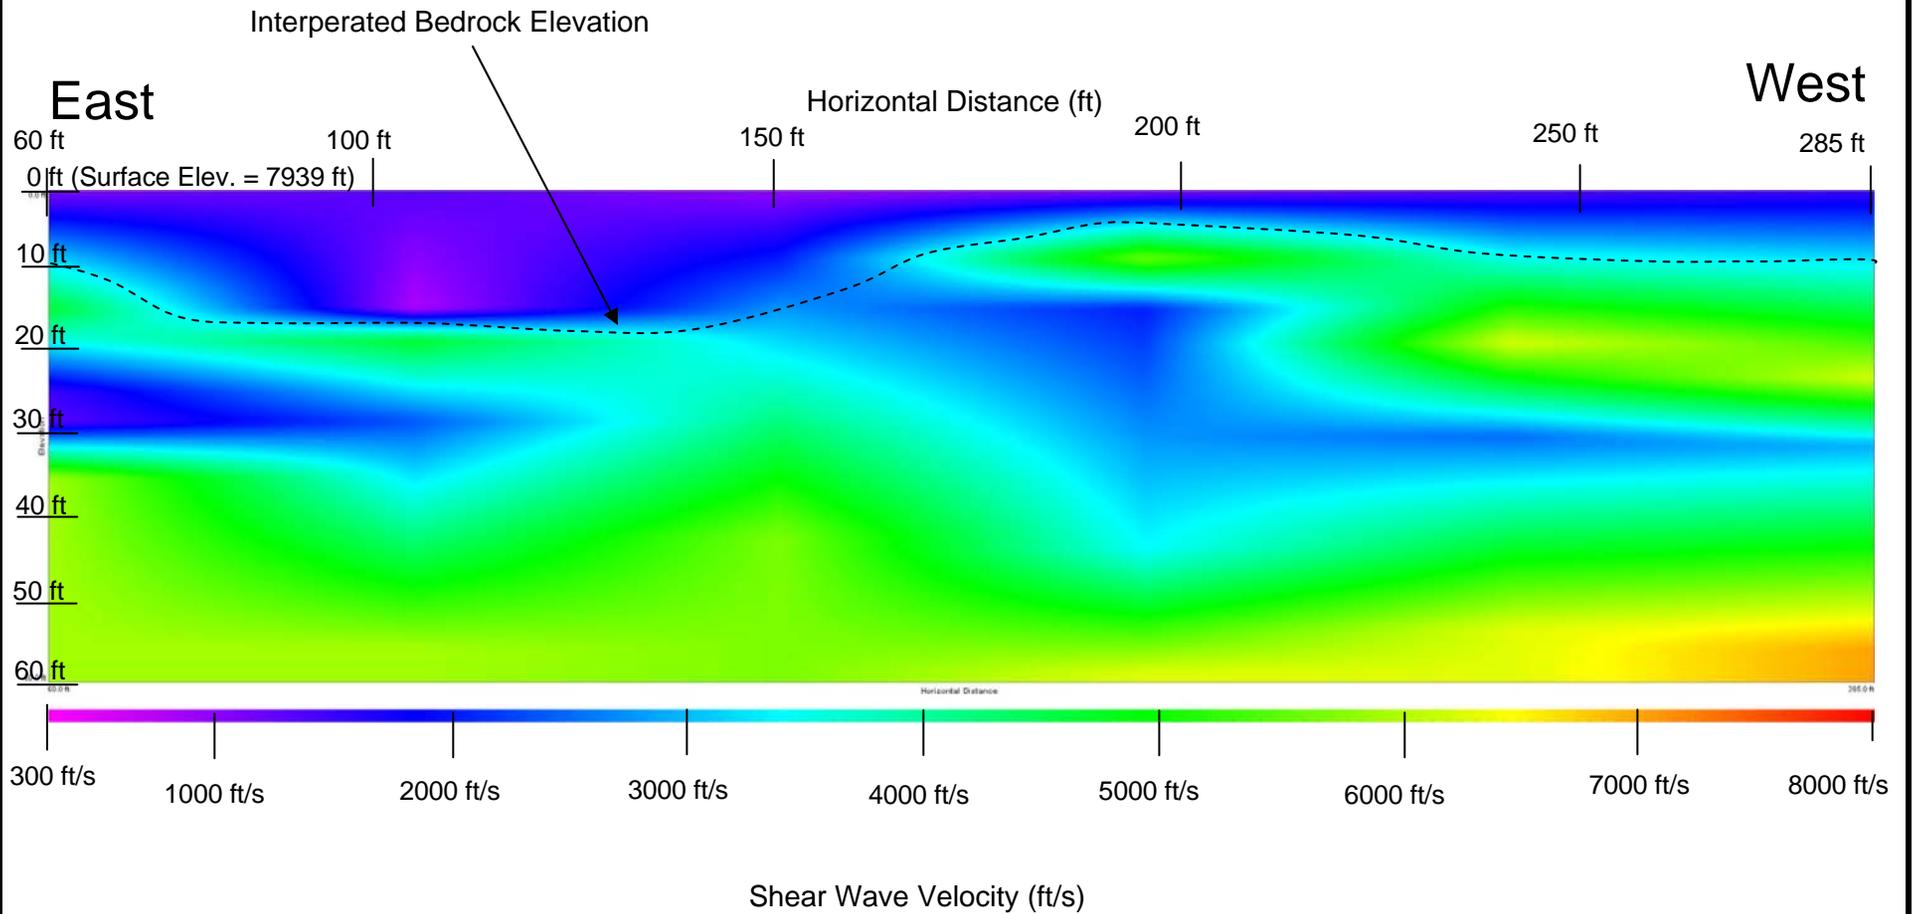
# Line B8 Profile

Line 8 Shear Wave Velocity Two-Dimensional Profile  
Hermosa Wind Project  
Tie Siding, Wyoming

Sandstone bedrock was generally described as cemented and fractured to highly fractured. Rock RQD values ranged from zero to as high as 72 with a general trend of increasing RQD with depth. Based on the geophysical testing, test location B-8 had shear wave velocities ranging from 3,500 to 6,500 feet per second (fps) with some softer zones, suggesting portions of the sandstone are highly weathered or uncemented.

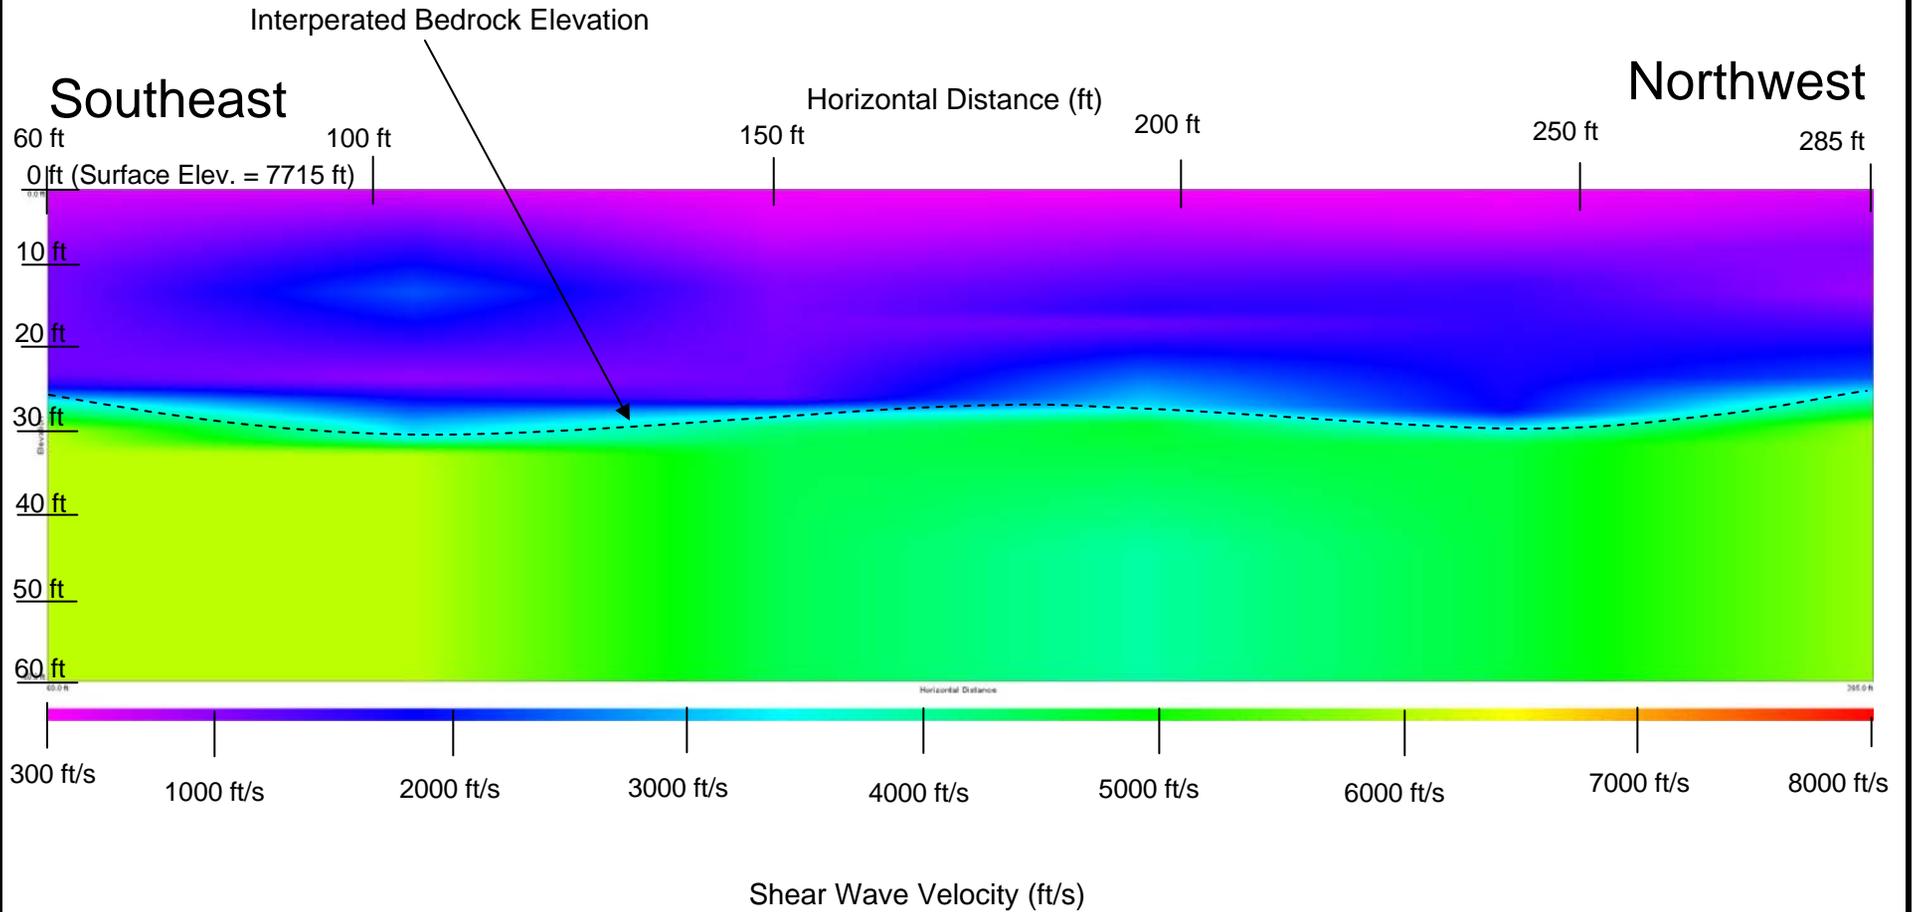
# Line B9 Profile

Line 9 Shear Wave Velocity Two-Dimensional Profile  
Hermosa Wind Project  
Tie Siding, Wyoming

Granite was generally described as fractured in parts with RQD values ranging from 20 to 60. Geophysical testing at yielded shear wave velocities that were slightly higher than the sandstone with values ranging from 4,000 to 8,000 fps.

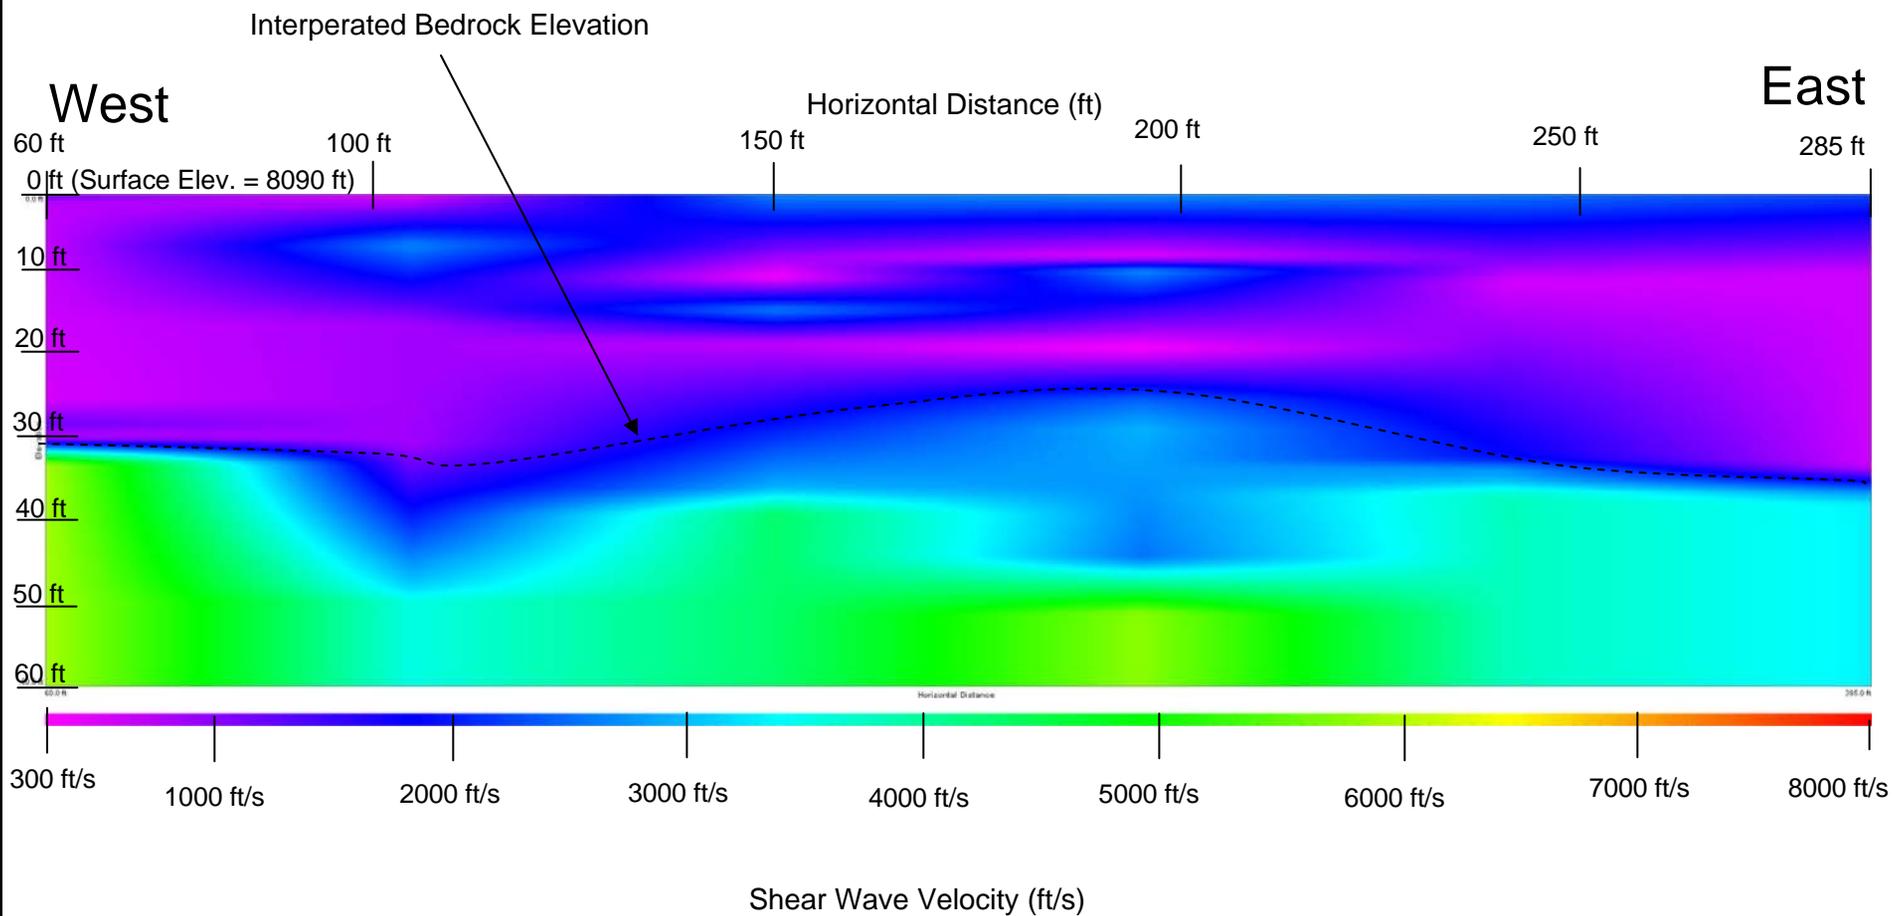
# Line B11 Profile

Line 11 Shear Wave Velocity Two-Dimensional Profile  
Hermosa Wind Project  
Tie Siding, Wyoming

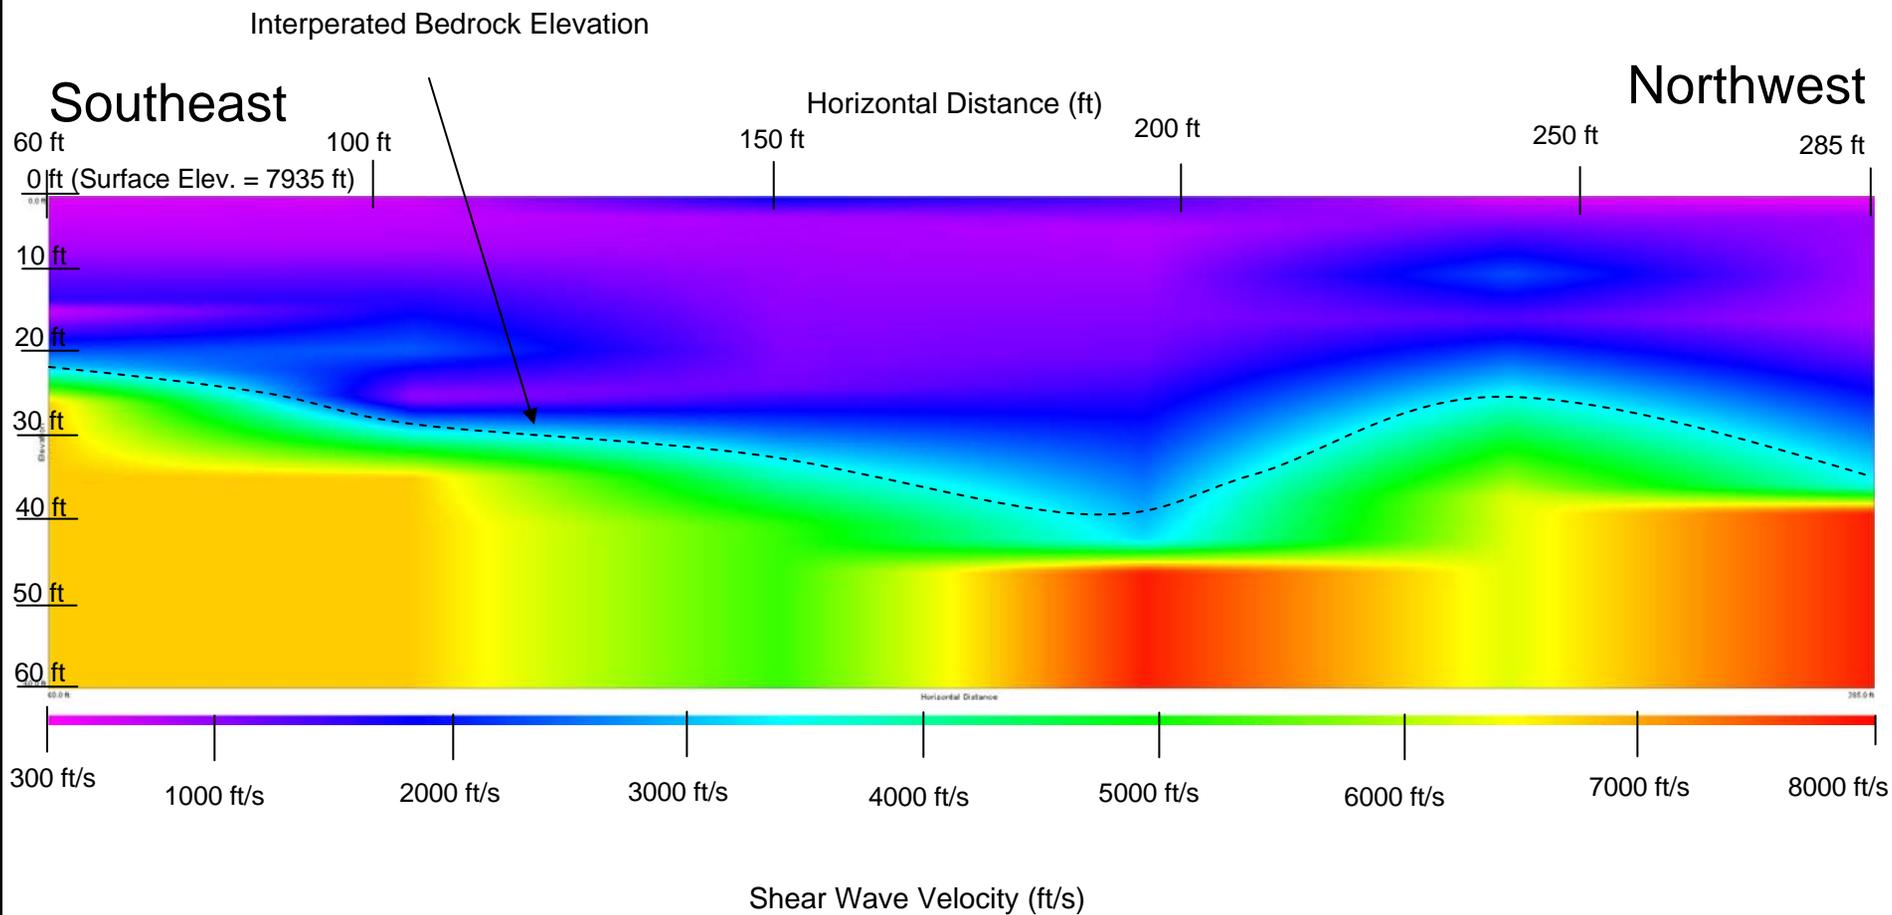
# Line B13 Profile

Line 13 Shear Wave Velocity Two-Dimensional Profile  
Hermosa Wind Project  
Tie Siding, Wyoming

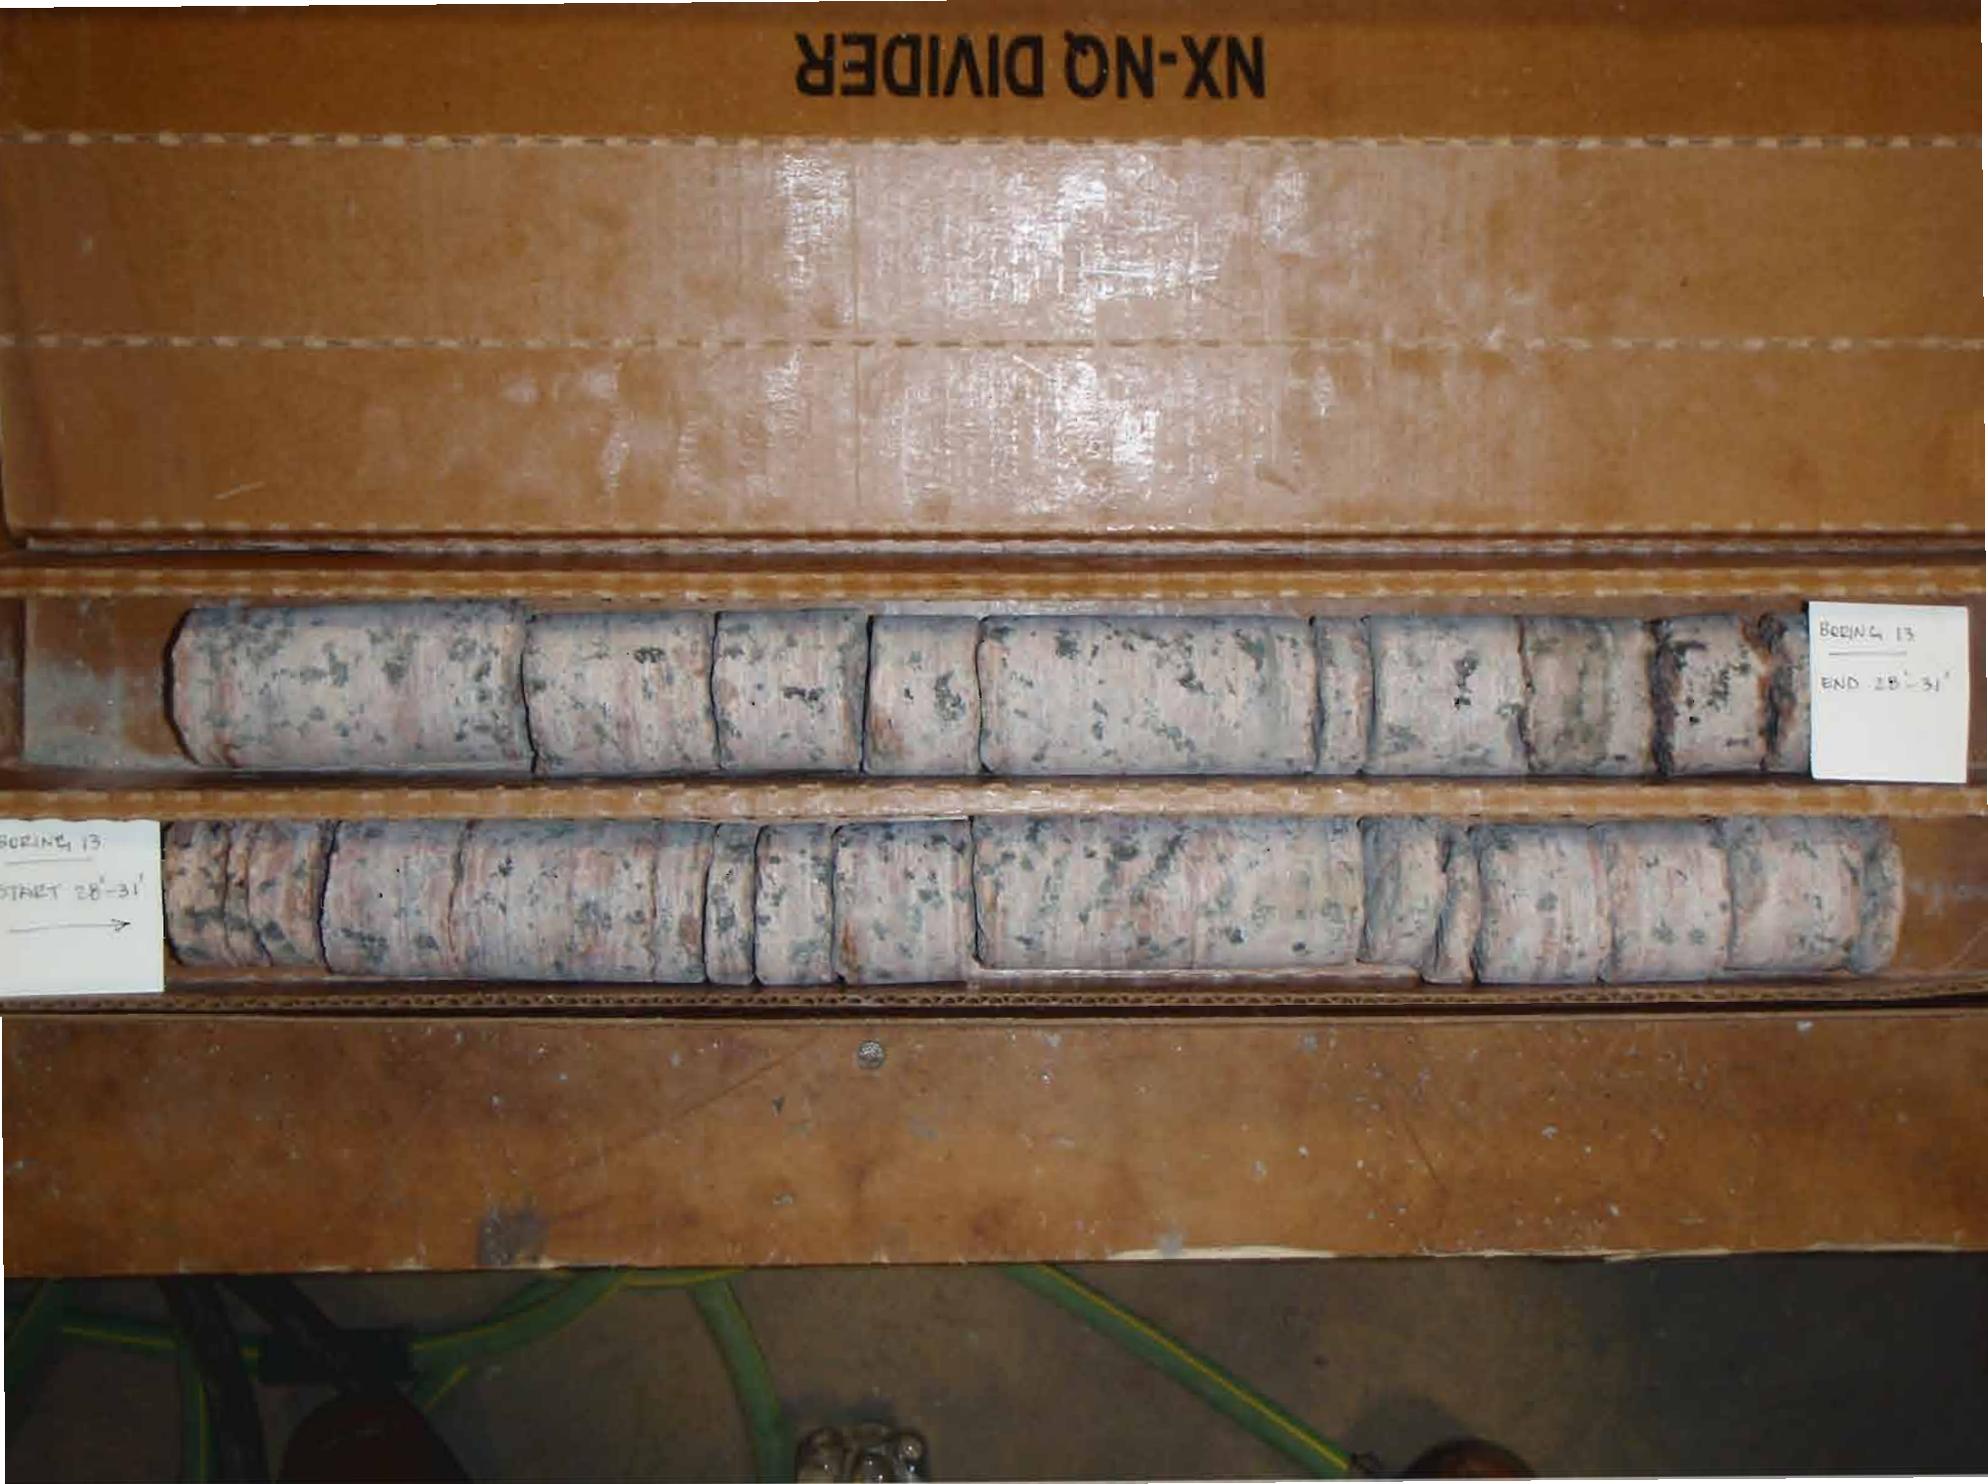
BORING, 13

START 28'-31'

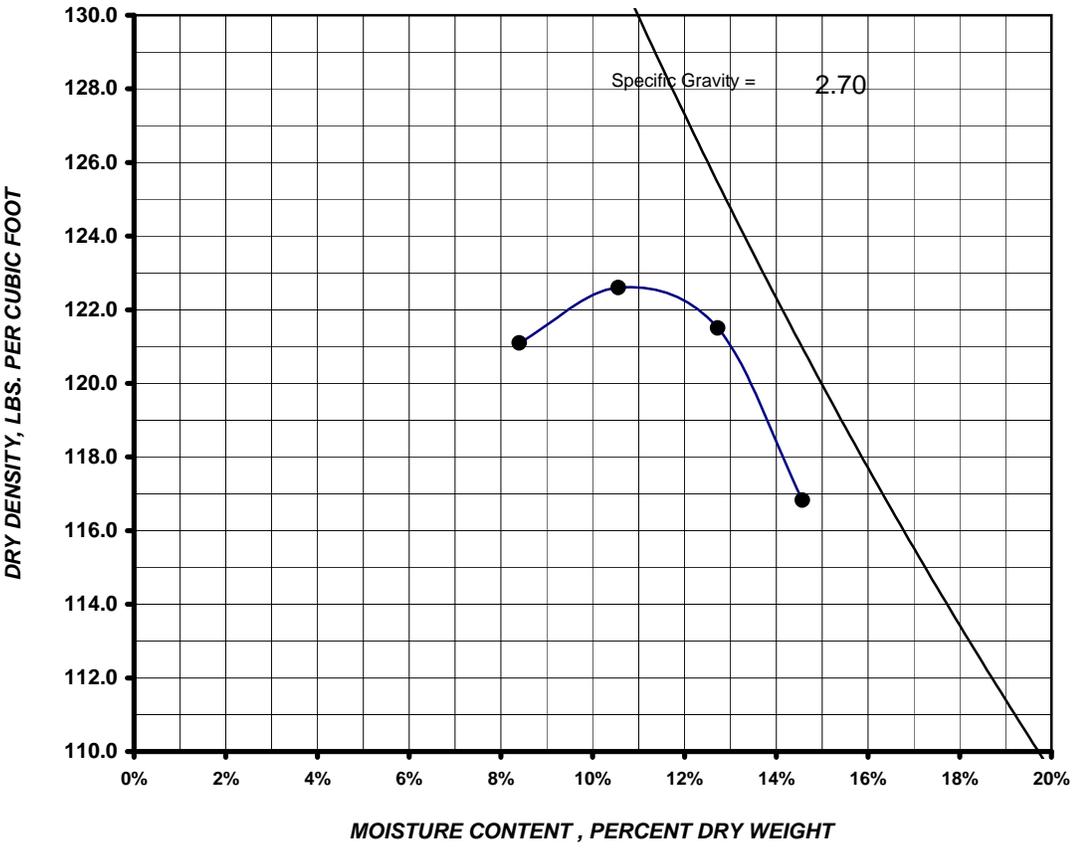
**Sample Source:** B10@0-5 ft  
**Sample Classification:** A-6 ( 3 ) CL Sandy Lean CLAY  
**General Description:**  
**Test Method:** ASTM D698 Method A  
**Rammer:** manual **Method of Preparation:** moist  
**Atterberg Limits (AASHTO T-89/T-90)**  
 LL: 29 PL: 18 PI: 11  
**Specific Gravity:** 2.70 (estimate)  
**Maximum Dry Density (pcf):** 122.6  
**Optimum Moisture Content (%):** 10.6

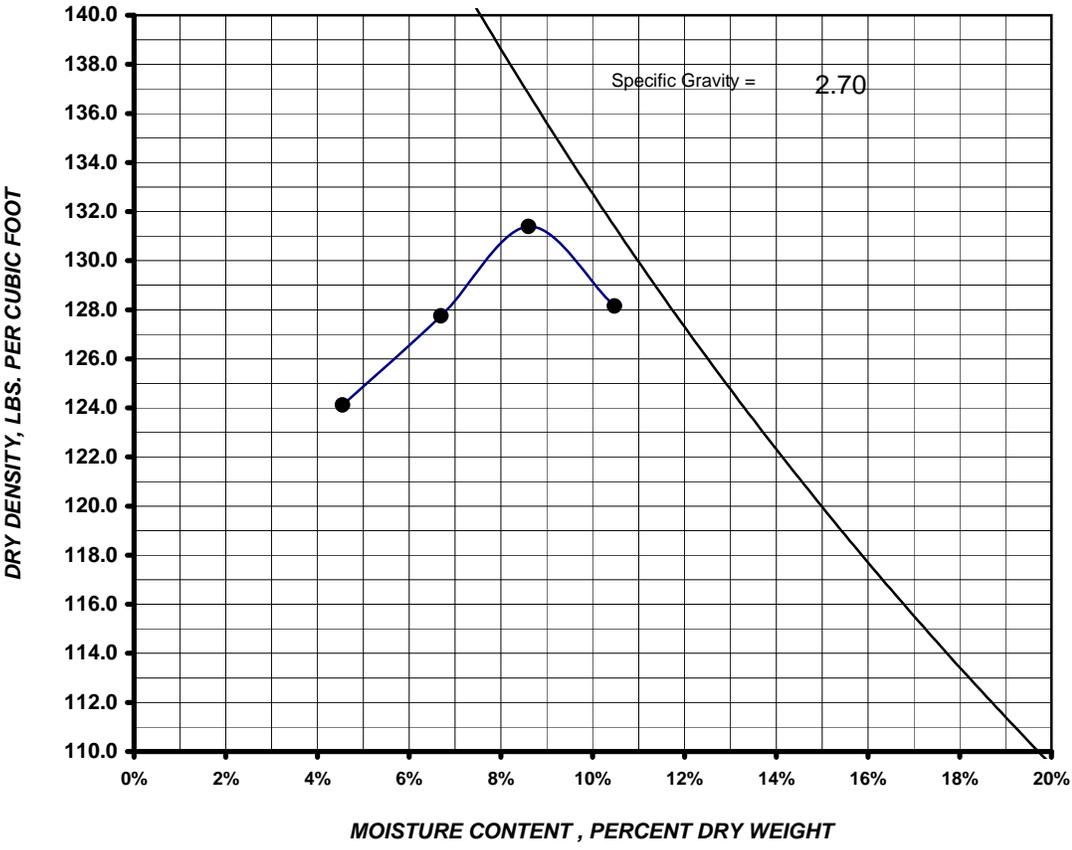
**Sample Source:** B13@0-5 ft  
**Sample Classification:** A-1-b ( 0 ) SP-SM Poorly graded SAND with Silt and Gravel  
**General Description:**  
**Test Method:** ASTM D698 Method B  
**Rammer:** manual **Method of Preparation:** moist  
**Atterberg Limits (AASHTO T-89/T-90)**  
LL: NL PL: NP PI: NP  
**Specific Gravity:** 2.70 (estimate)  
**Maximum Dry Density (pcf):** 131.4  
**Optimum Moisture Content (%):** 8.6
