**APPENDIX N**  
**PRELIMINARY GEOTECHNICAL INVESTIGATION RESULTS**

Shell Wind Energy, Inc  
Hermosa Wind Project

Subject: Preliminary Geotechnical Investigation Results

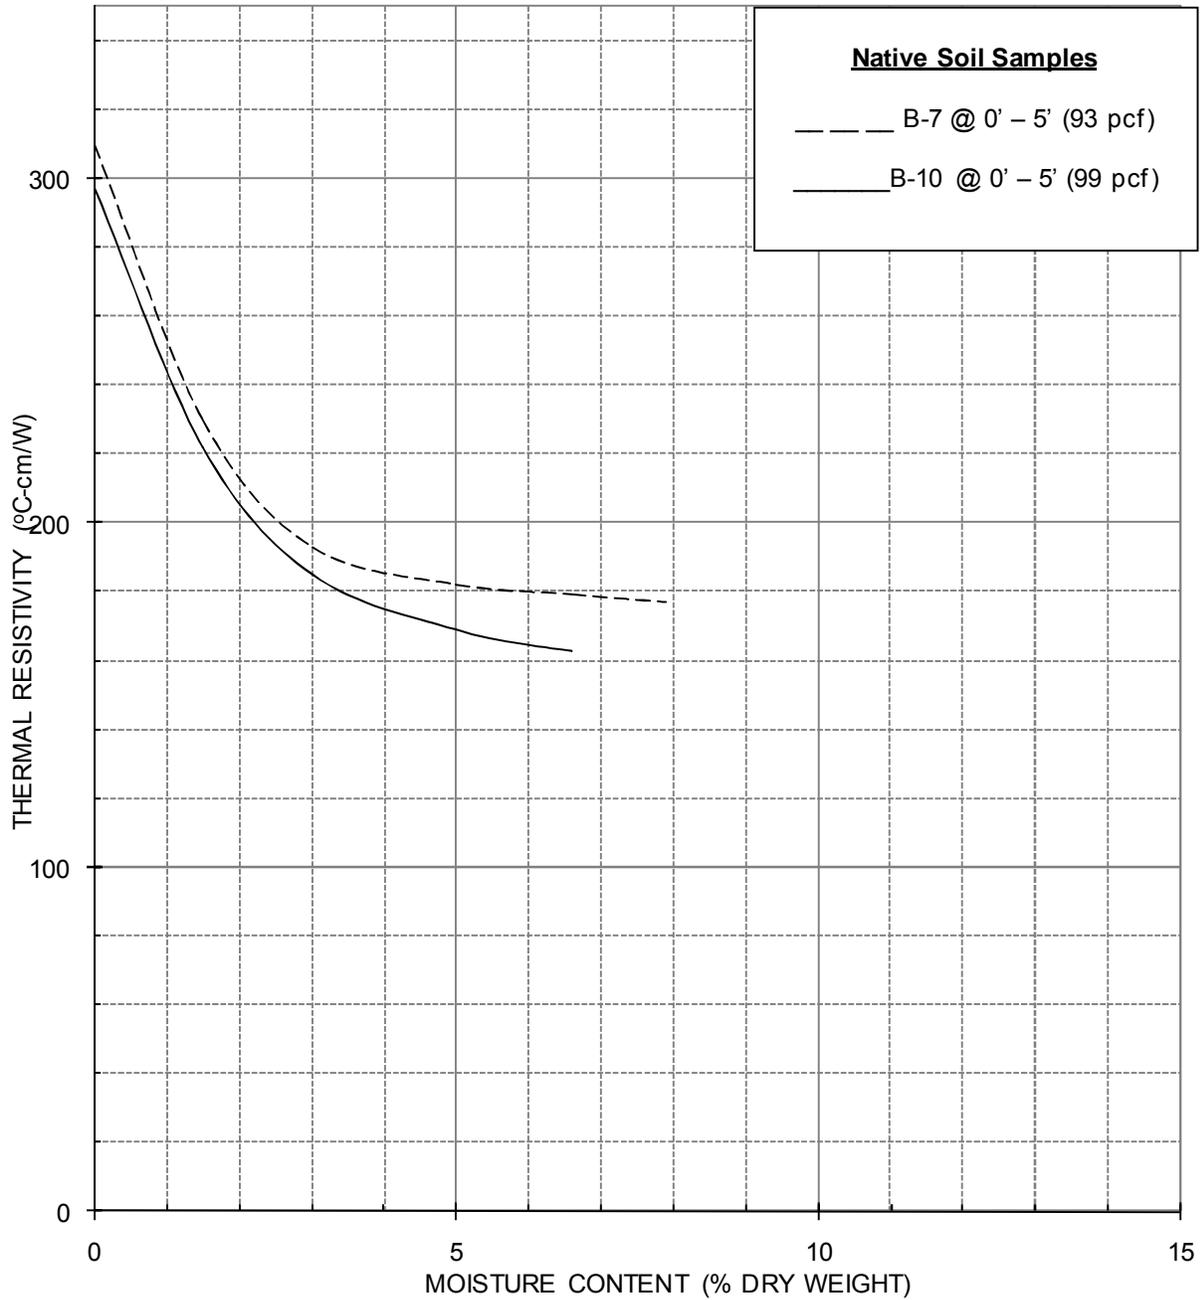
### THERMAL DRYOUT CURVE

**Professional Services Inc**  
**Thermal Analysis of Native Soil Samples**  
**Hermosa Wind, Project # 535-95048**

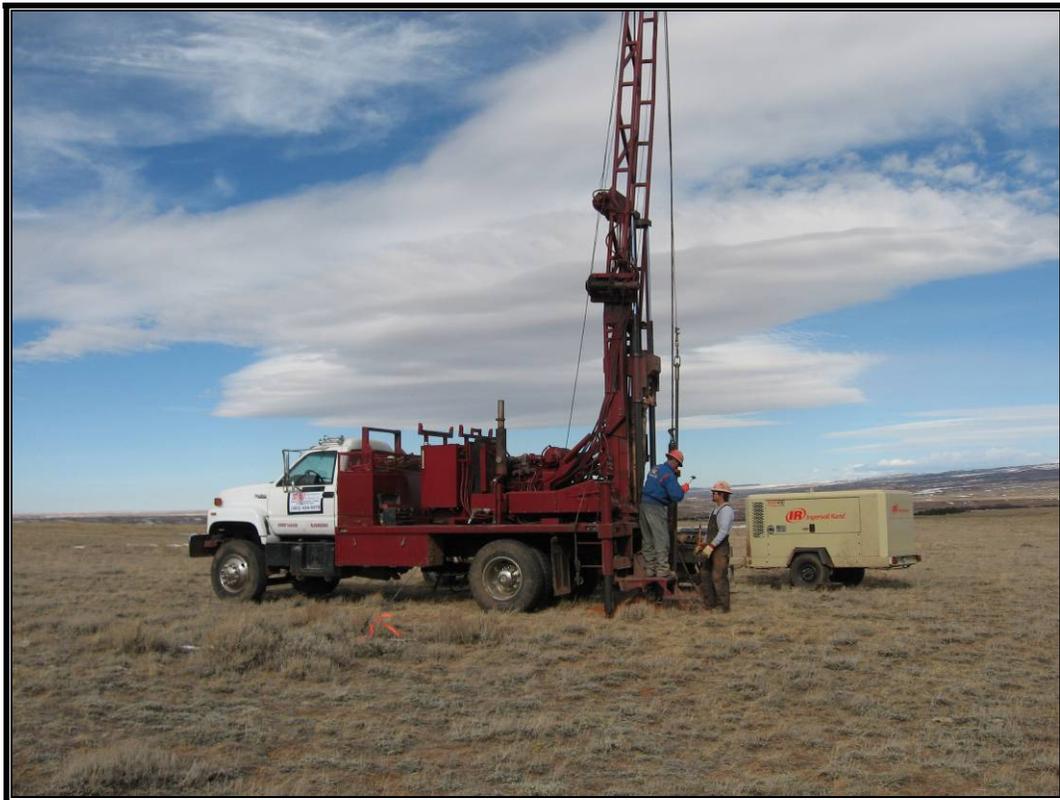
Figure 6. Showing drilling equipment and its minimal impact. Photo taken near B7 in Township 13N, Range 73W, Section 28.

An intensive pedestrian Class III cultural resource survey was conducted over 100 percent of the project area encompassing 30 acres of private and Wyoming state land. An area of at least 2.5 acres was inventoried at each location and any necessary access was inventoried using a 60 m wide corridor from the nearest existing road. The drilling of the geotechnical bore holes was monitored by an on-site archaeologist. All seven bore locations were inventoried on October 26, 2009. Monitoring was conducted on the six accessible bore holes between November 2–5, 2009. There was little disturbance to the areas bored because the drill rig is designed to have little impact on the bored location (Figure 6).

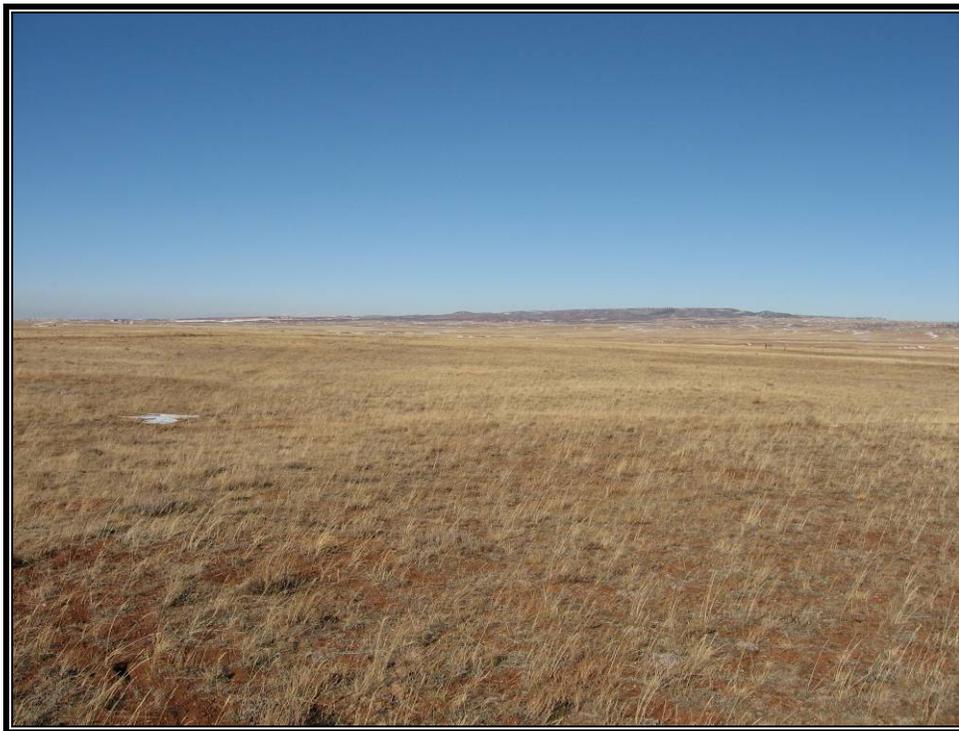
Figure 7. Overview of B7, facing east.

This bore hole is located at approximately 7,800 ft AMSL on a gently sloping area with a northeast aspect (Figure 7). Just to the south of the bore location is a small intermittent drainage that made access impossible for the drill rig. This led to the inventory of a 375-x-60-m strip to the nearest allowable access road. No cultural resources were located in this additional inventory area. The sediments at this location were gravel filled sand 10 ft deep. These sediments lay on top of sandstone bedrock. The vegetation at this location shows evidence of grazing and has some low grasses and interspersed forbs across it. The nearest permanent water is Government Creek, 0.3 mi to the southwest.

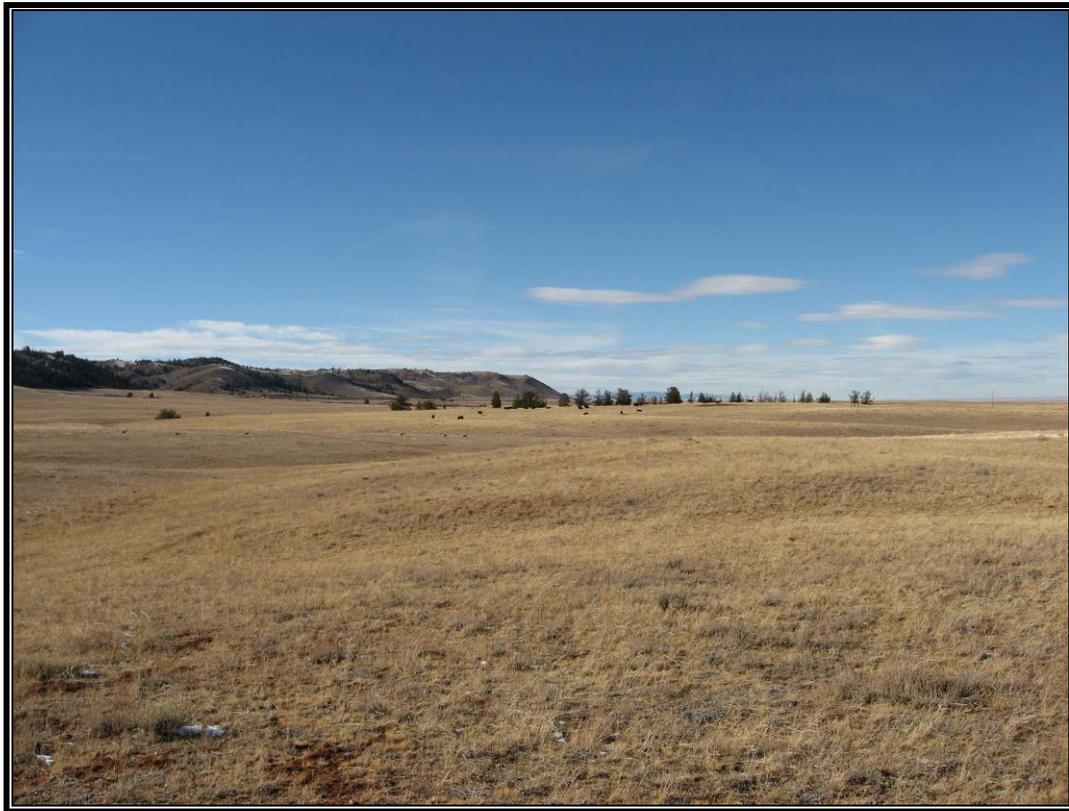
Figure 8. Overview of B8, facing northwest.

This bore hole is located at approximately 7,900 ft AMSL on a small rise in the center of a wide rolling plain (Figure 8). Vegetation here consisted of low grasses and forbs with conifers visible in the drainage to the northwest. The sediments at the location are a gravel filled sandy loam is 8 ft deep. Underneath the sediments is a friable sandstone bedrock. The nearest permanent water is Boulder Creek, located 0.6 mi to the north.

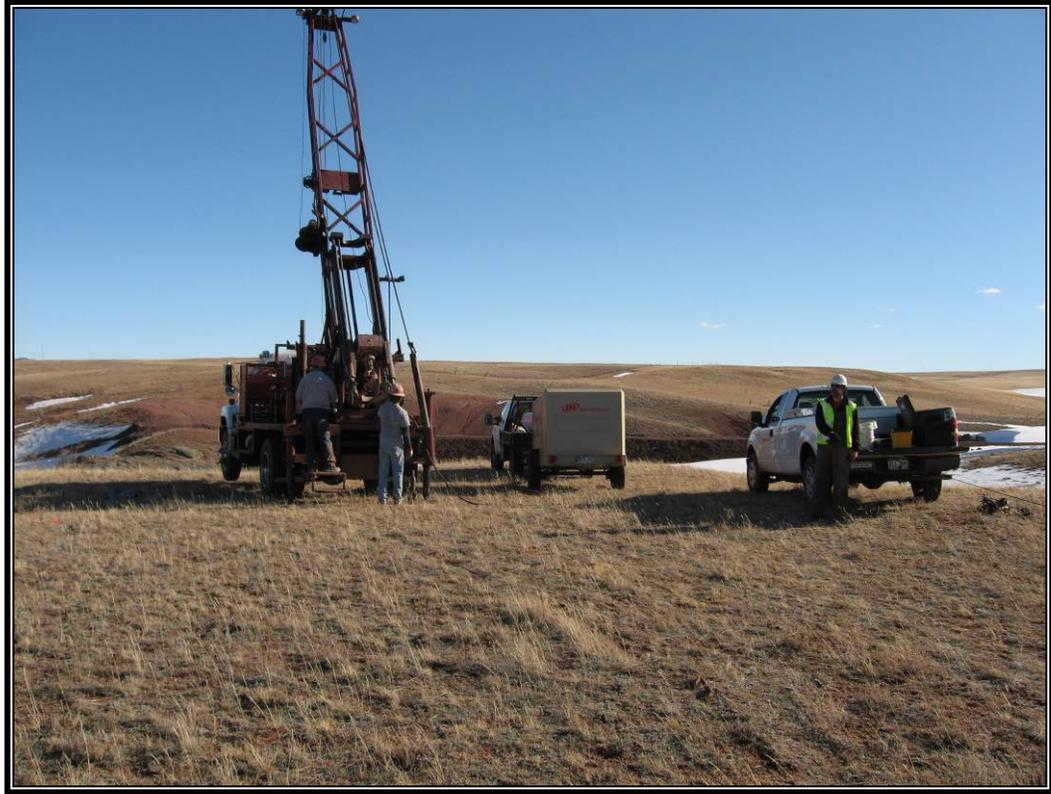
Figure 9. Overview of B9, facing south.

This bore hole is located at approximately 7,720 ft AMSL on a flat overlooking Boulder Creek less than 0.1 mi to the south (Figure 9). The sediments here were a packed residual granitic gravel 35 ft deep. These overlaid an orthoclase-rich granitic bedrock. Proximity to water and lack of slope made this landform a higher probability area for cultural resources

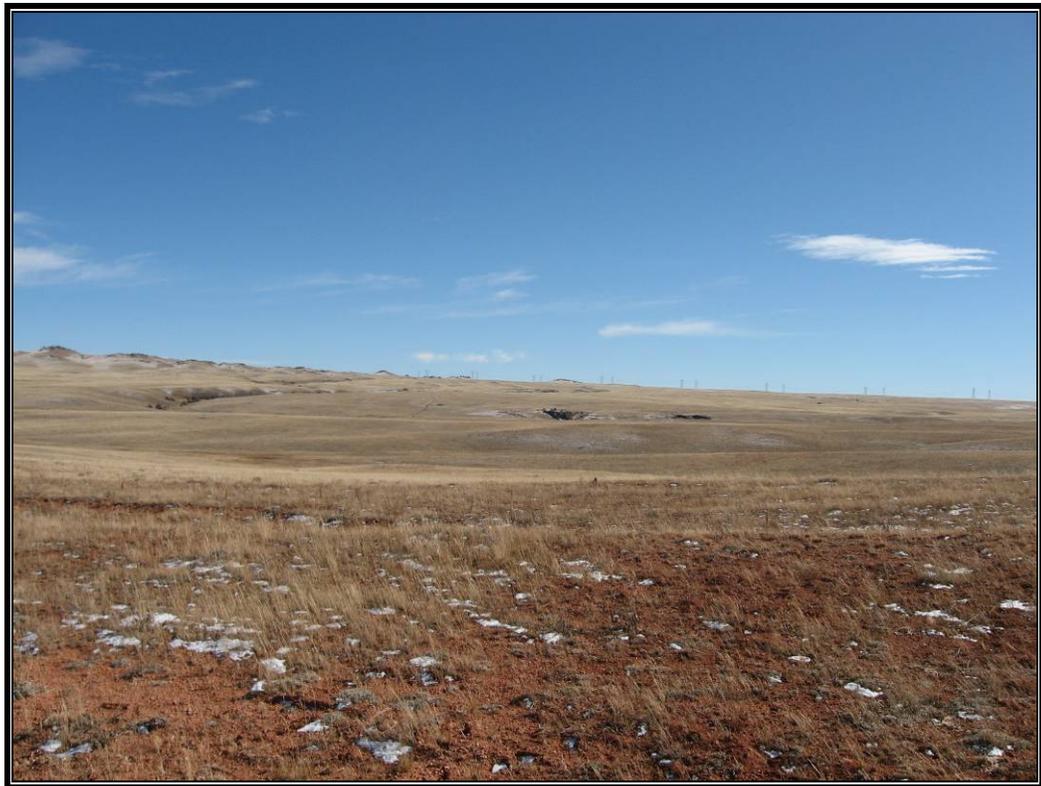
Figure 10. Overview of B10, facing northwest.

This bore hole is located at approximately 7,810 ft AMSL located on a rounded rise that slopes to the east (Figure 10). The sediments at this location consisted of 10 ft of compacted sandy clay with gravel in it. This high concentration of clay was not seen anywhere else in the project area. The underlying bedrock was sandstone and was easily cored. There was very little vegetation at this site. This could be due to the group of pronghorn that we saw near the location on several occasions. There was almost no grass left and only intermittent forbs growing in the bore area. The nearest permanent water is Willow Creek, 0.5 mi to the southeast.

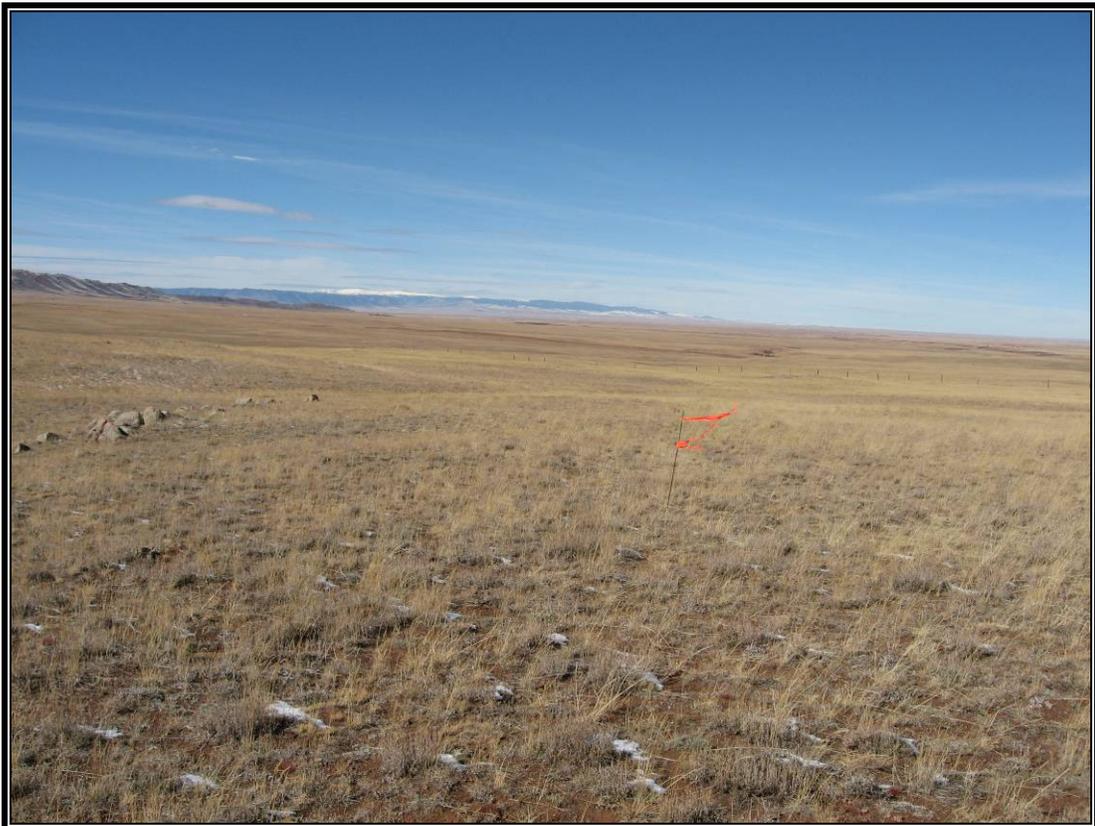
Figure 11. Overview of B11, facing northwest.

This bore hole is located at approximately 8,070 ft AMSL on the center of a small rise. The sediments were residual and sandstone derived (Figure 11). These sediments were less than 5 ft deep. These sediments overlaid a highly fractured sandstone bedrock that no core sample could be recovered from. Vegetation consists of highly grazed low grasses with some forbs. The nearest permanent water is an unnamed spring located 0.75 mi to the southeast.

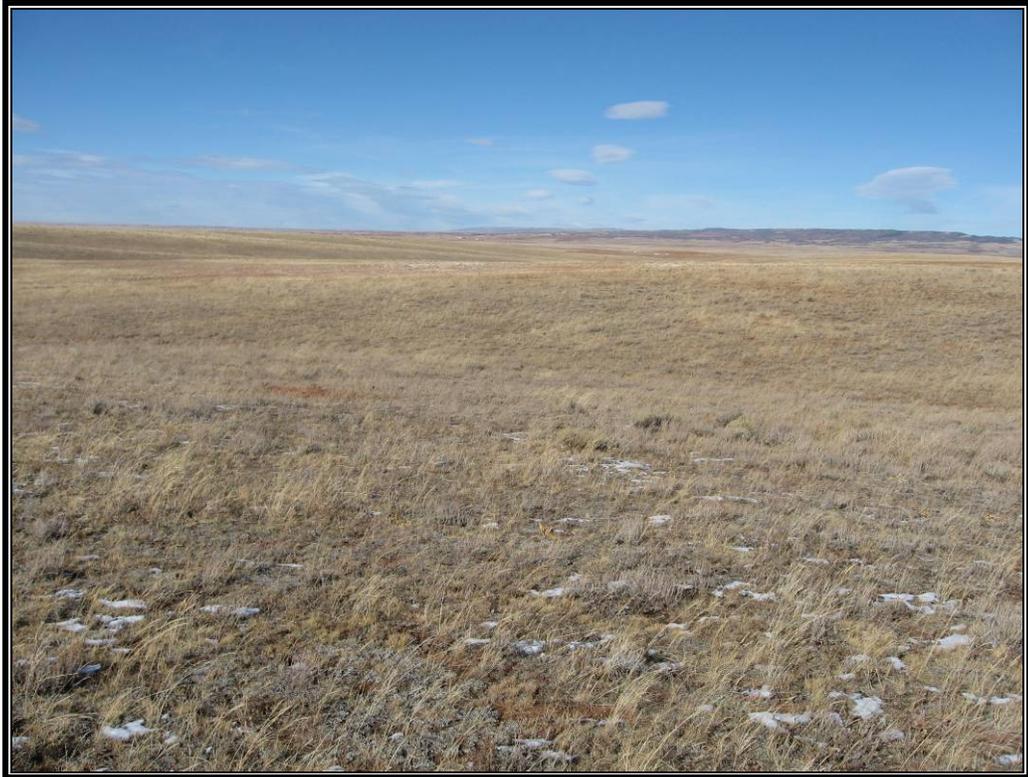
**Figure 12. Overview of B12, facing northwest.**

This unused bore location is located at approximately 7,900 ft AMSL on a flat to the west of a significant unnamed ridge with abundant rock outcropping (Figure 12). This bore location was inventoried, but not drilled since remnant snow drifts from the previous weeks storms precluded access. Vegetation at

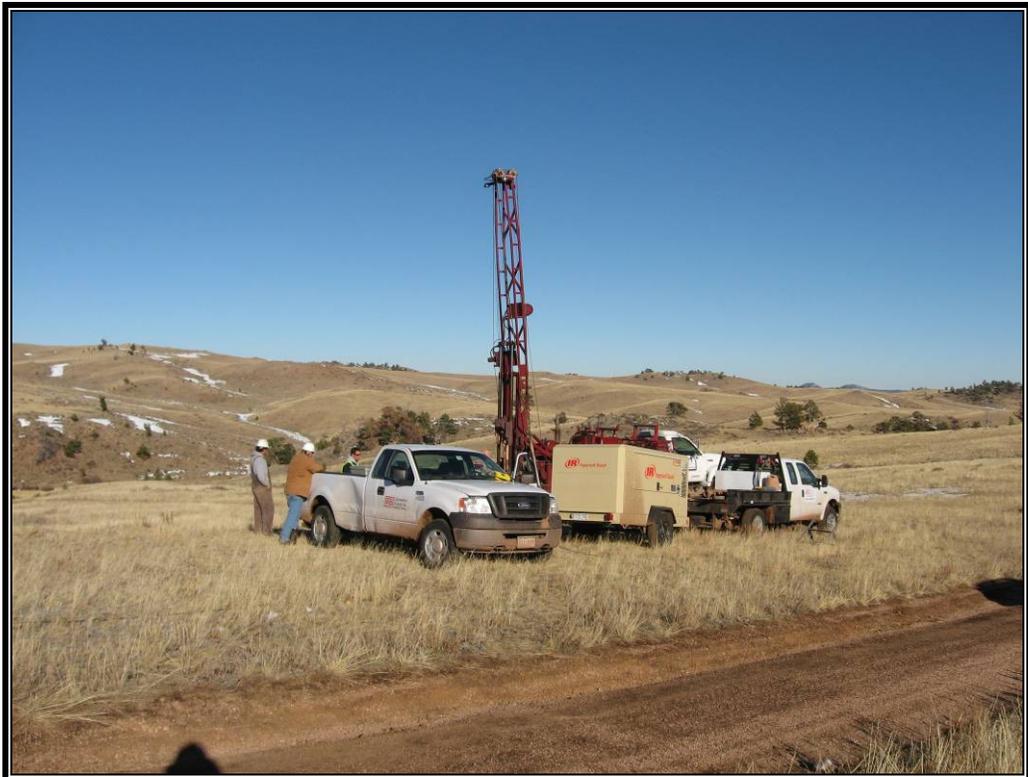
**Figure 13. Overview of B13, facing northeast.**

This bore hole is located at approximately 7,900 ft AMSL on the north side of a small ridgeline above Fish Creek (Figure 13). The area has outcropping granitic rock to the east, southeast, and west. The vegetation is Low grasses and Forbs, with pine trees on the knolls to the east and west. The sediments are 27 ft deep in the bore location and overlay a very dense, orthoclase-rich granitic bedrock. Sediments are sandy and compacted with high concentrations of granitically derived gravel. The nearest permanent water is Fish Creek, 0.2 mi to the northeast.

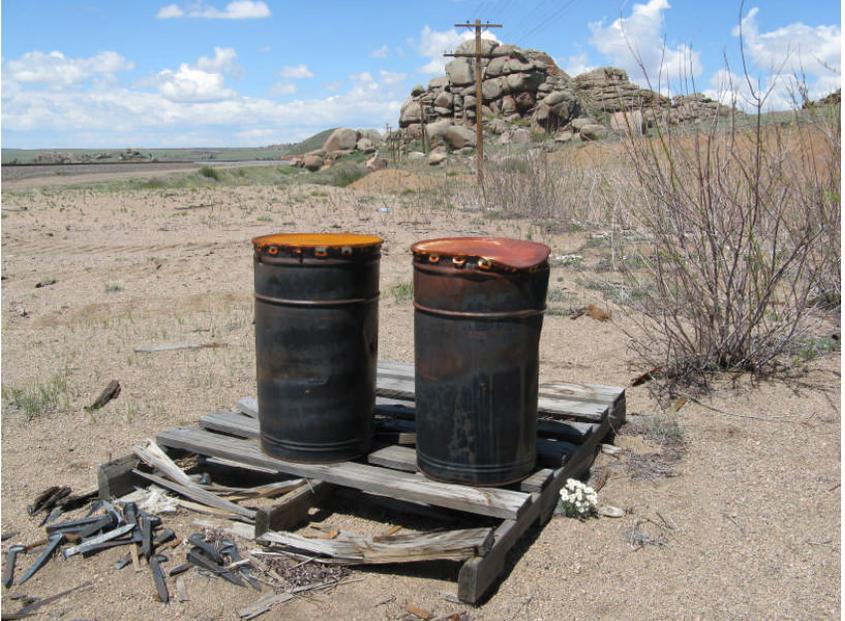
<p><b>Date</b> 5/27/09</p>	
<p><b>Direction</b> W</p>	
<p><b>GPS Point</b> 13</p>	
<p><b>#16</b> View of two full cans of liquid, which appeared to be oil for railroad switch maintenance.</p>

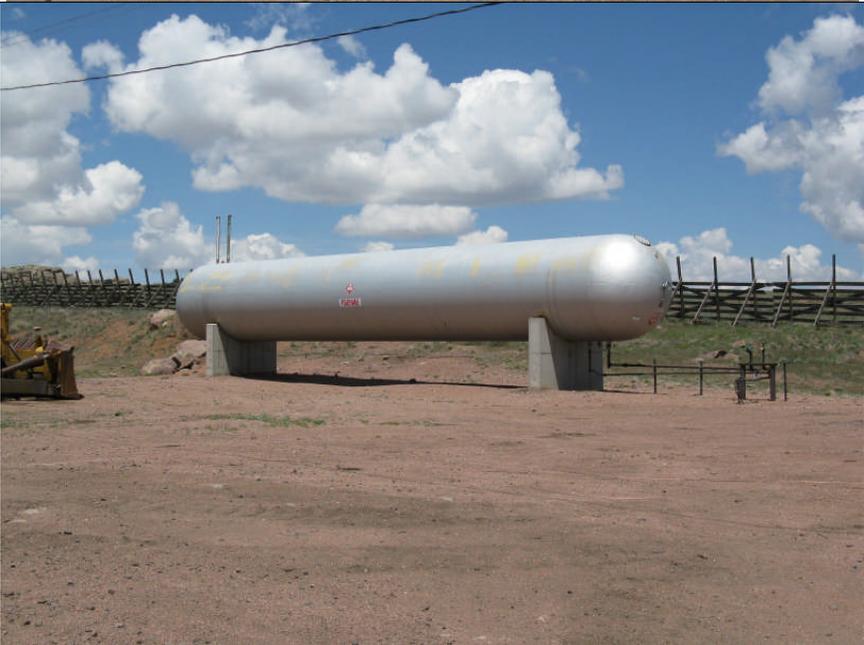
<p><b>Date</b> 5/27/09</p>	
<p><b>Direction</b> NW</p>	
<p><b>GPS Point</b> 16</p>	
<p><b>#18</b> View of a propane tank at Dale Junction.</p>

- Aboveground Storage Tanks (ASTs): Two (2) propane tanks were observed in the Project Area. One was observed at near a rail switch in “Dale Junction” along the railroad at Point # 16 (Photograph #17, #18, and #19) in Figure 4 and next to a cellular telephone tower at Point # 25 (Photograph #27 and #28). No evidence of a release was observed at either of these tanks.

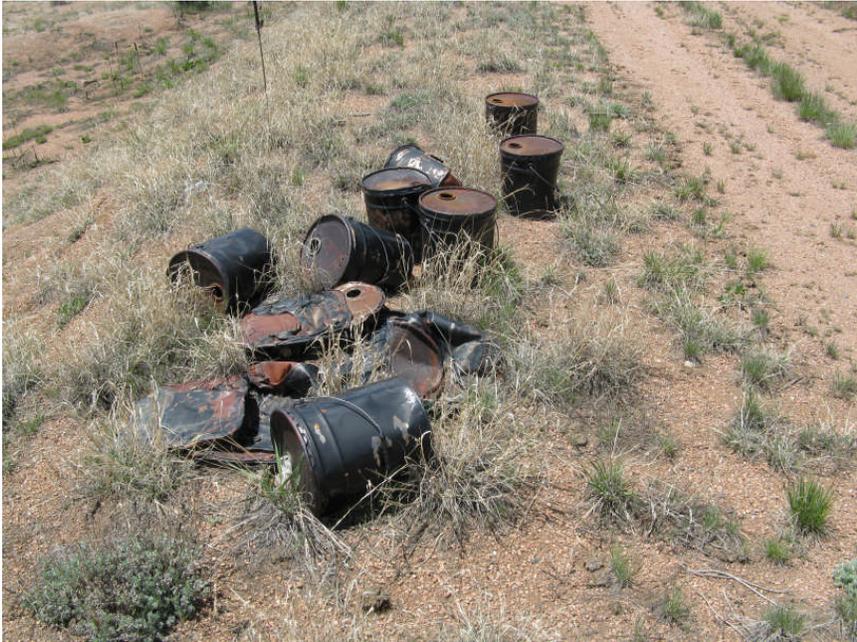
A photograph showing a tall wooden utility pole with multiple cross-arms and insulators. To the right of the pole is a white metal utility shed with a sign that reads "DALE JCT. C.P. W 545". The background shows a rocky, hilly landscape under a blue sky with scattered clouds.
<p><b>Date</b> 5/27/09</p>	
<p><b>Direction</b> W</p>	
<p><b>GPS Point</b> 16</p>	
<p><b>#20</b> View of empty oil buckets next to the railroad, showing lack of evidence of staining of the ground or stressed vegetation.</p>

A photograph showing several empty, rusted metal oil buckets scattered on the ground. The ground is dry and sandy with sparse, dry vegetation. A dirt road or railroad track runs through the scene.
<p><b>Date</b> 5/27/09</p>	
<p><b>Direction</b> W</p>	
<p><b>GPS Point</b> 17</p>

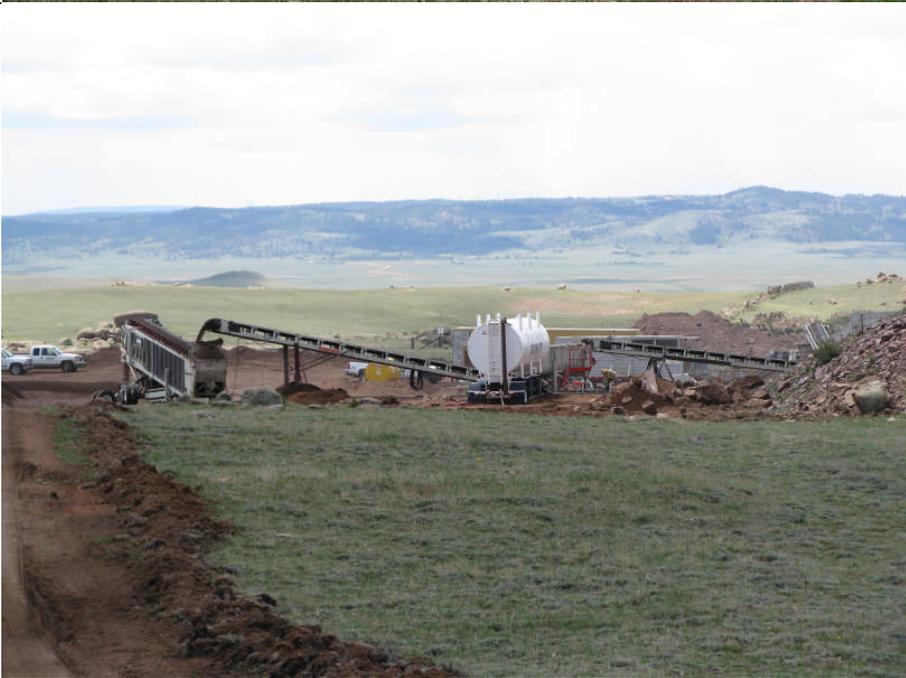
**#22**  
View of the same quarry showing a mobile, diesel fuel vessel for excavating equipment.

The Hermosa Project Area is located primarily on lands that were purchased from the Bureau of Land Management (BLM) by private entities, as well as approximately 6,316 acres of state owned public lands in the northeastern, central and southeastern portions of the Project Area. Four small parcels of BLM land border the Project Area; two on the northeast and two on the east side of the Project Area. According to the United States Geological Survey (USGS) Landcover Inventory, the Project Area contains no range or agricultural lands, however, E & E observed pastures for cattle grazing throughout the Project Area, primarily on private lands. According to aerial imagery and topographic maps, there appear to be no cities located within the Project Area boundaries. One residence was observed during the site survey within the Project Area on property owned by Bath Family Ltd. Partnership, just south of Point #13 on the Site Observations Map (Figure 4). Two towns, Hermosa and Tie Siding, are located just outside of the north-central border of the Project Area. According to the USGS Topographic Map (Figure 2), there are two ranches adjacent to the Project Area. . One ranch is located to the west of the northeastern portion of the Project Area near Dale Creek. The other ranch is located immediately to the west of the entire Project Area. Two former mines are also depicted in the topographic map, outside of the Project Area and east of Route 287. In addition, E & E observed an active quarry in the Project Area near Point #18 (Photograph #21 and #22) in Figure 4 of this report.

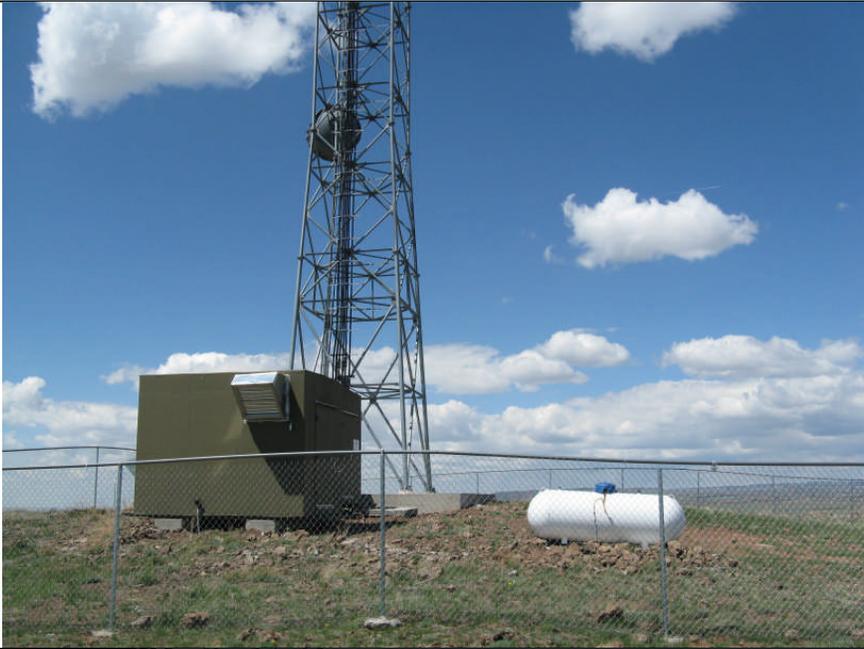
<p><b>#27</b> Cell phone tower and fuel gas tank on Fischer property of the SP.</p>

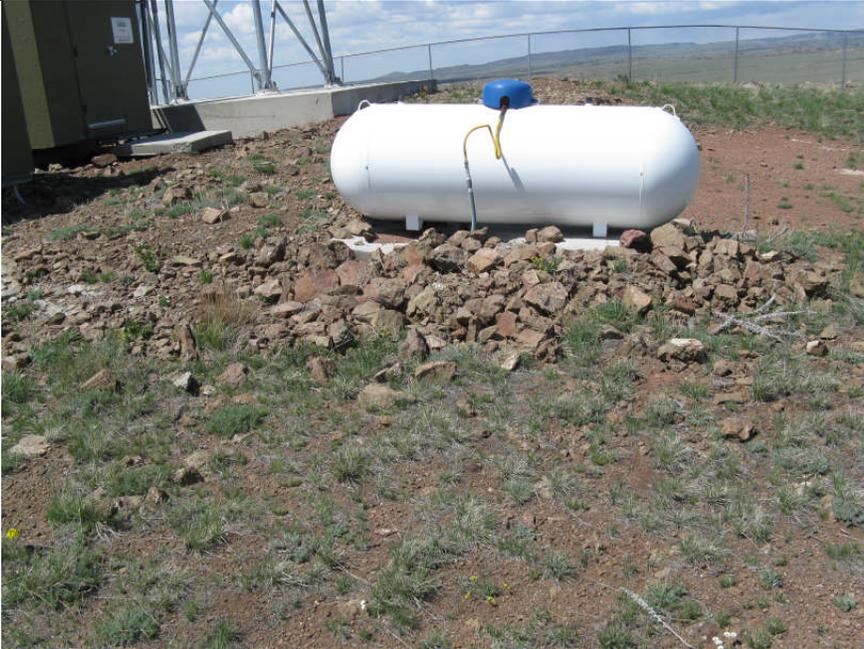
A photograph showing a tall, lattice-structured cell phone tower on a hillside. In the foreground, there is a green utility box and a white cylindrical fuel gas tank. The area is enclosed by a chain-link fence. The sky is blue with scattered white clouds.
<p><b>Date</b> 5/27/09</p>	
<p><b>Direction</b> N</p>	
<p><b>GPS Point</b> 25</p>	
<p><b>#28</b> Close up of the tank.</p>

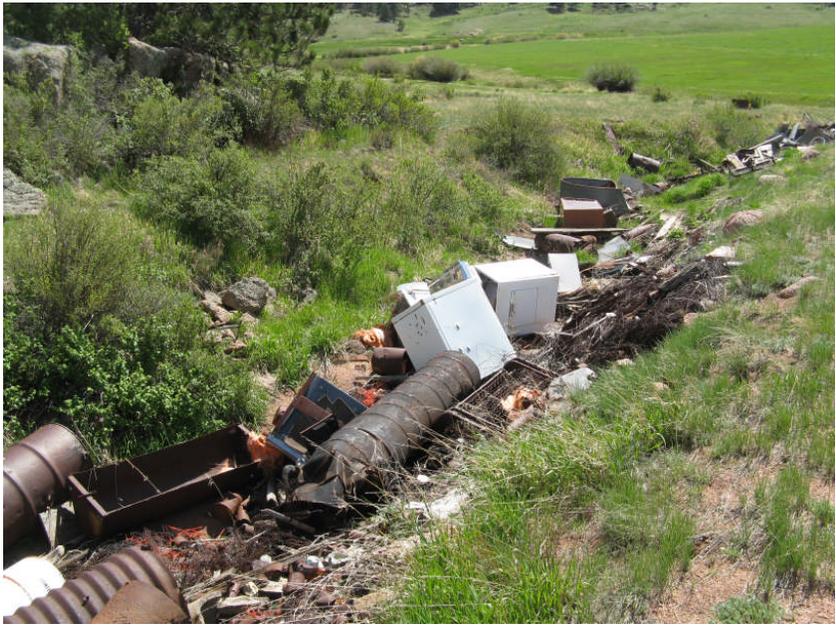
<p><b>Date</b> 5/27/09</p>	
<p><b>Direction</b> S</p>	
<p><b>GPS Point</b> 29</p>	
<p><b>#32</b> View of scrap metal, empty drums, trash, conduits, empty cans and containers, appliances, metal troughs, etc. on the Fischer property of the SP.</p>

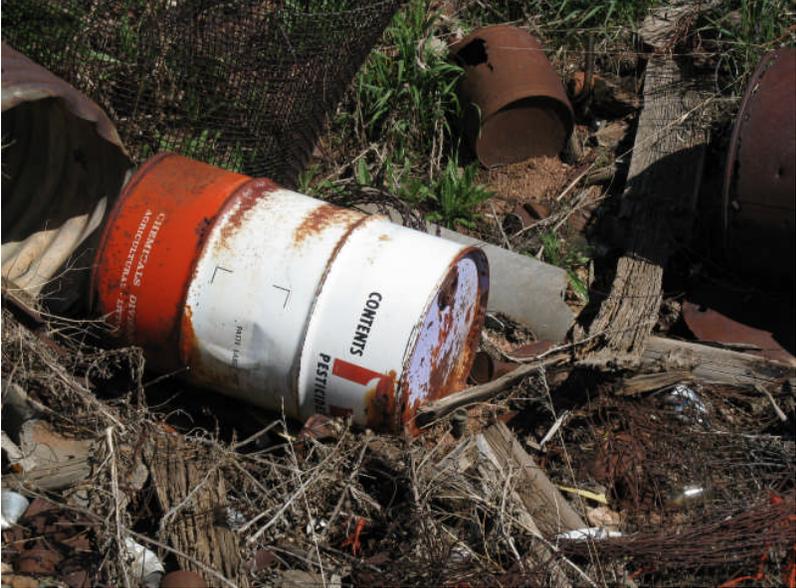
<p><b>#33</b> View of same dump showing an empty pesticide drum and other empty containers.</p>

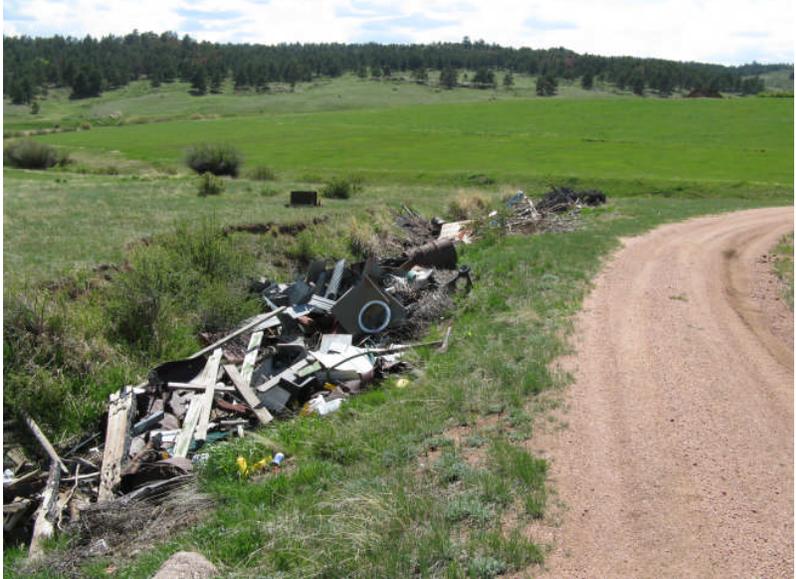
<p><b>Date</b> 5/27/09</p>	
<p><b>Direction</b> SE</p>	
<p><b>GPS Point</b> 29</p>	
<p><b>#34</b> Another view of the same dump and road on the SP.</p>

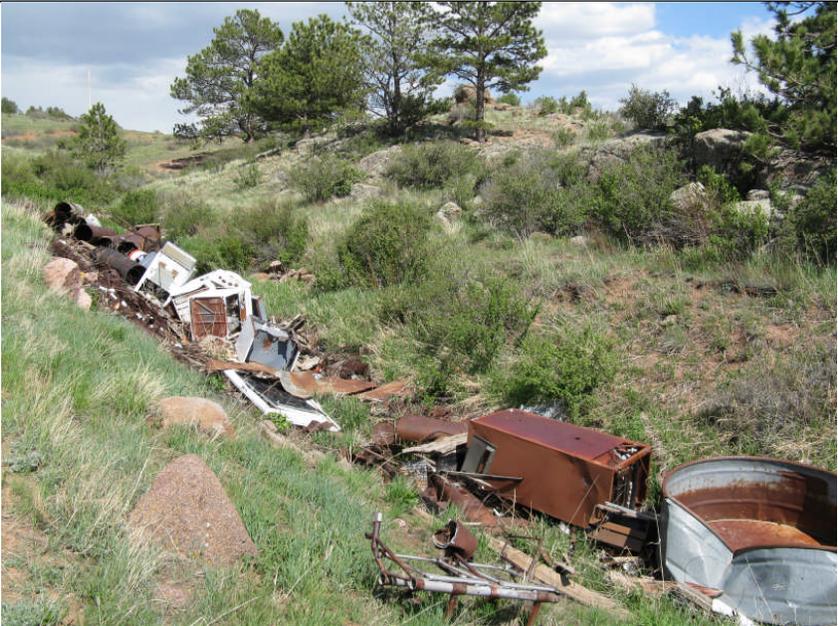
<p><b>#35</b> Another view of the same dump.</p>

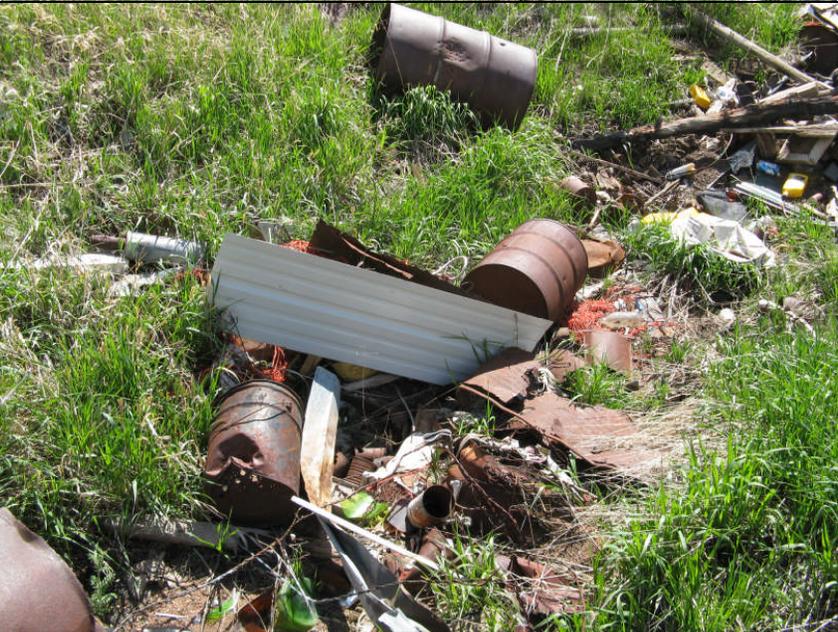
<p><b>Date</b> 5/27/09</p>	
<p><b>Direction</b> NE</p>	
<p><b>GPS Point</b> 29</p>	
<p><b>#36</b> Another view of the same dump area.</p>

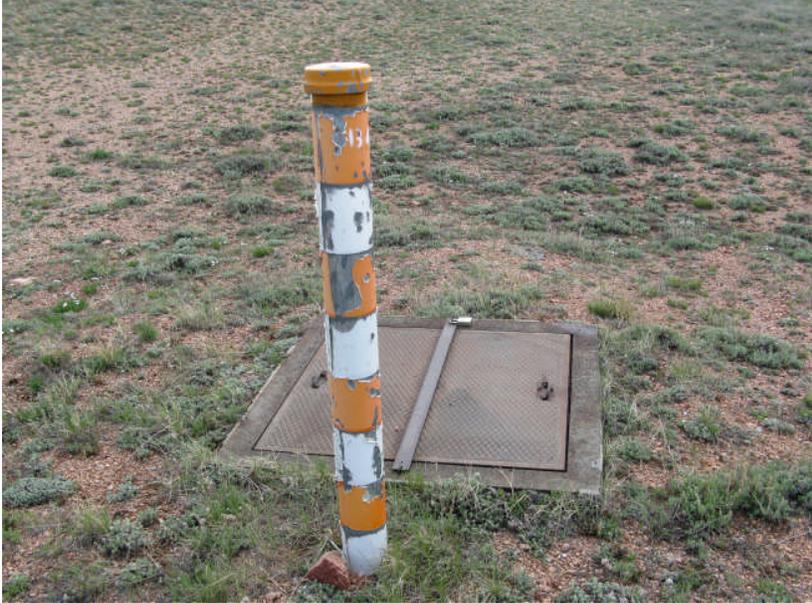
<p><b>Date</b> 5/27/09</p>	
<p><b>Direction</b> NW</p>	
<p><b>GPS Point</b> 34</p>	
<p><b>#40</b> View of a SP pipeline marker and hatch near the boundary of Bath property and state land.</p>
